# Failure Mode Analysis of Automotive Final Drive Gears

**Abstract.** After repeated complaints from customers about failure, the crown and pinion assembly of the vehicle was analyzed by standard metallurgical methods. Standard material composition of the part was confirmed by chemical analysis. Tooth contact analysis was done to understand the contact and sequence of failure. Micro hardness test was done to understand about the hardness of the specimen. The nature of fracture is studied by subjecting the specimen to micro-structural study. It was found that the effect of combination of low case hardness and improper composition was augmented by improper alignment while assembling caused premature failure of the component.

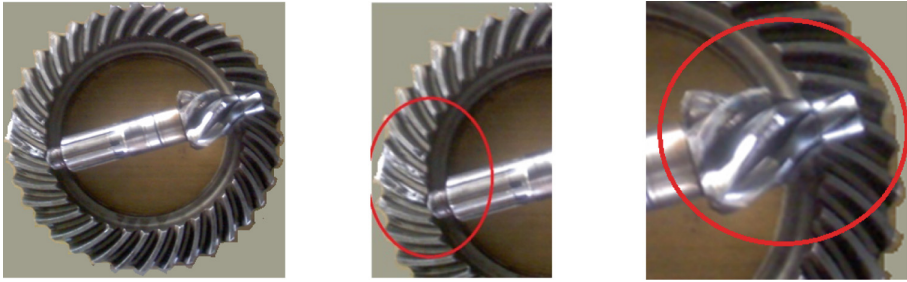
**Fig. 1.** Failed crown and pinion

From standards, the life expectancy of the failed part should have been between 150000 km and 200000 km. During visual inspection, cold weld on the edge of the broken tooth of the gear were found. There were indications showing that the crown wheel and pinion were relatively new. The pinion had sub case fatigue initiated by fine cracks. Large fragments have been removed from the teeth. The gear also had fatigue beach marks.

En353 (15 Ni Cr 1 Mo12) [for heavy- duty applications] and En 207 (20Mn Cr1) [for medium applications] are the two common billet materials used to manufacture these gears. Though pitting is found to be less, in the components, relatively large pitting on the pinion than on the crown wheel indicates that the failure is premature and not due to pitting.

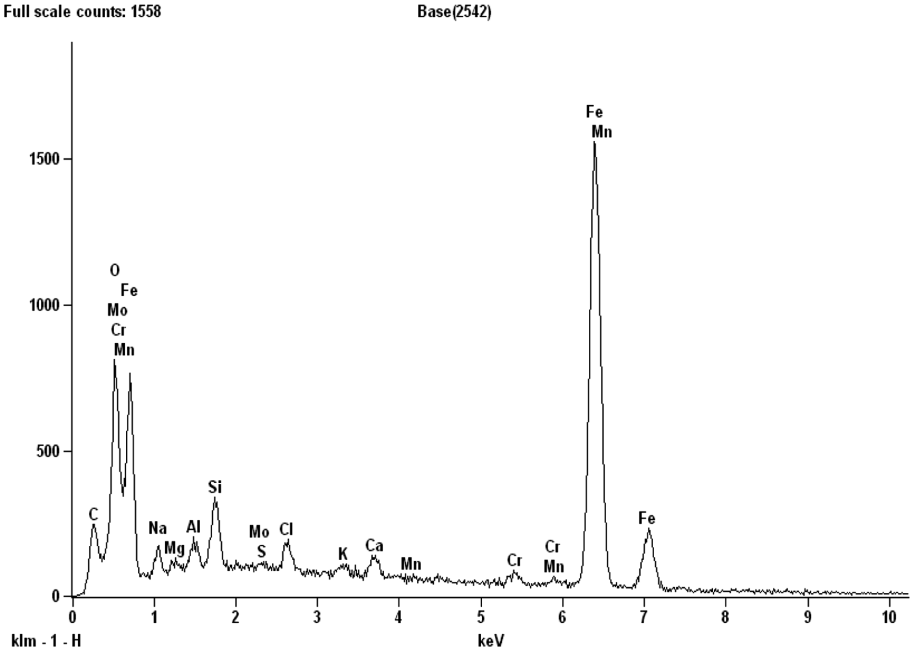
The EDX analysis [5] done on new component and failed component are shown in Figs. 2 and 3 respectively. It was learnt that En353 was used to manufacture the parts. The carbon equivalent (CE) for the failed component was found to be 0.77. From the chemical analysis it was understood that one of the reason of failure was wrong selection of material. Also, the manufacturer had changed the composition by increasing percentage of manganese. This reduced the carbon content which resulted in low core hardness. This modification also contributed to premature failure of components. Tables 1 and 2, respectively, shows chemical analysis result for new and failed components.

Fig. 2. EDX analysis done on good surface

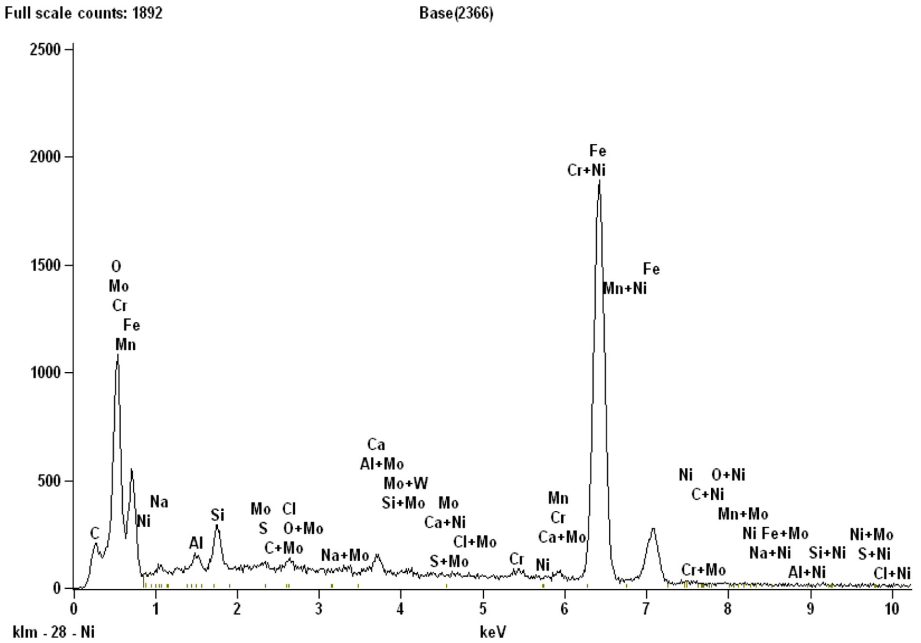
Fig. 3. EDX analysis of damaged surface

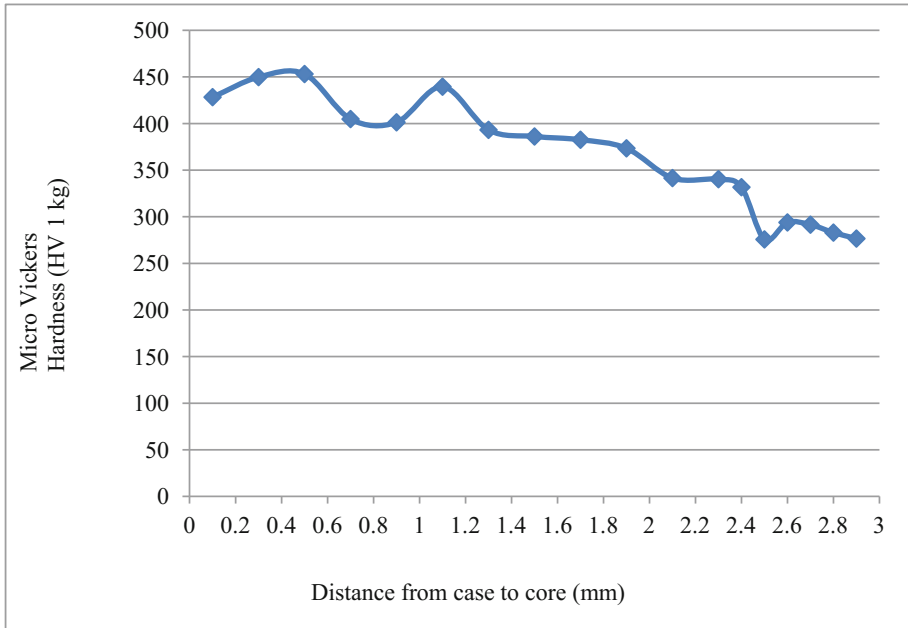
Case carburized material has varying hardness from the case to the core. Micro hardness survey gives a better picture on this. For the failed gear, core hardness was measured near the center of base of the damaged tooth. The measured hardness is 276.6 HV, whereas the desired core hardness is between 317 and 401 HV. This means that the failed part had very low case hardness. It can be concluded that the low hardness also contributed to the premature failure (Figs. 4, 5 and 6).

**Fig. 4.** Micro hardness graph

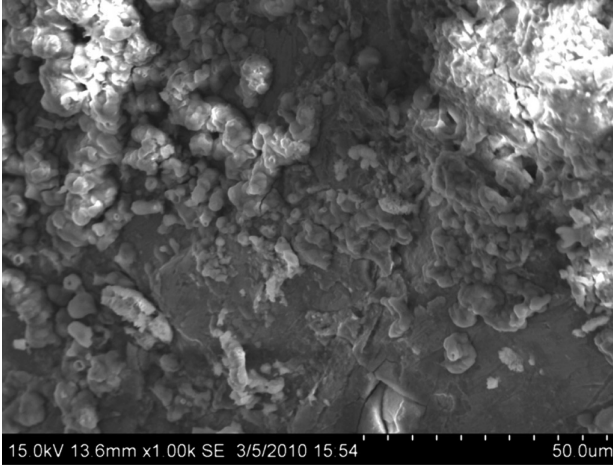
**Fig. 5.** SEM image of the failed part

Fractography would reveal the nature of fracture in a component. A portion of the failed part was cut and is subjected to micro structural study using scanning electron microscope [SEM]. The case and core micro structure of the failed component are shown below. The study revealed that the mode in which the fracture has occurred is highly brittle in nature. This is evident by the cleavage facets. The SEM images of the specimen are shown in the following figures.

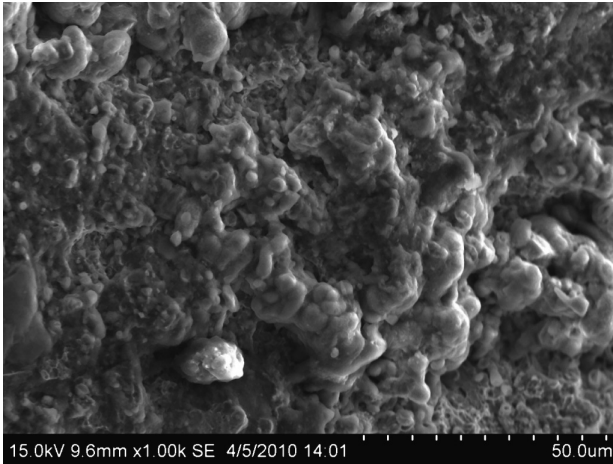
**Fig. 6.** SEM image of original part
