Investigation of Degradation in Crystalline Silicon Photovoltaic Modules After 10 Years Exposition in Senegal by Infrared (IR) and Electroluminescence (EL)

Abstract. The effects of a sub-Saharan coastal climate on PV modules degradation was studied in this paper. A Mono and a polycrystalline-silicone solar PV module exposed in Dakar, dry and coastal climate, at the extreme West of Senegal was studied. As first inspection in this region, the electrical parameters of two PV modules A and B operated during about 10 years, are measured under standard testing condition (STC) and their I-V characteristics were fitted. The initial I-V characteristics was performed under real conditions and translated to STC and compared to the measured I-V characteristics at standard test conditions (STC) obtained in PV Laboratory after exposition. After the operating years, the main important parameters of the studied PV modules: short-circuit current I_{SC} , open circuit voltage U_{OC} , maximum power P_{MPP} , nominal current I_{MPP} and Voltage V_{MPP} are evaluated and then compared to the initial parameters obtained during initial exposition to estimate their degradation.

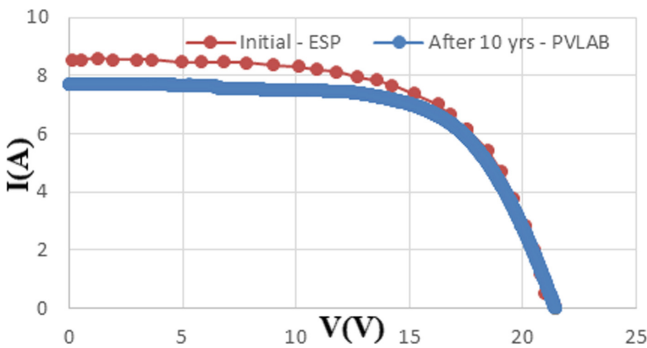
Fig. 7. I-V characteristics of monocrystalline module (A). (Color figure online)

The realization of this curve IV in comparison with the initial curve already shows degradation of certain performance characteristics. The short-circuit current I_{SC} from 8.56 A to 7.75 A is the most affected characteristic. Therefore, the maximum power current I_{MPP} is affected. Initially the maximum power of 114 W obtained with I_{MPP} of 7.02 A decreases by 6.095 W. The maximum power current thus becomes 6.67 A.

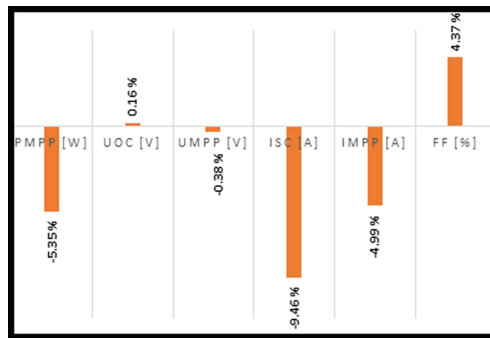
Fig. 8. Performance degradation of module A.

From Fig. 8, it can be seen that the open-circuit voltage is not affected because the calculated degradation is positive. The U_{MPP} also expresses a very slight degradation of just -0.38% . However, the nominal and short circuit current degradation is striking and equal to -4.99% and -9.46% respectively, which is generally caused by mismatched cells and increase sometimes series resistance increase. Such kind of IV distribution and I_{SC} reduction refer to irradiation decreases or shaded cells. In general, this is the consequences of operating area reduction or cells properties inhomogeneity. Also, a non-homogeneous temperature distribution could be expected by thermal imaging to confirm the aging of this module. The considerable degradation of I_{MPP} particularly affects the maximum power which is degraded by -5.35% . The fill factor degradation rate is also positive, meaning that the theoretical power degradation is more important than the maximum power diminution.

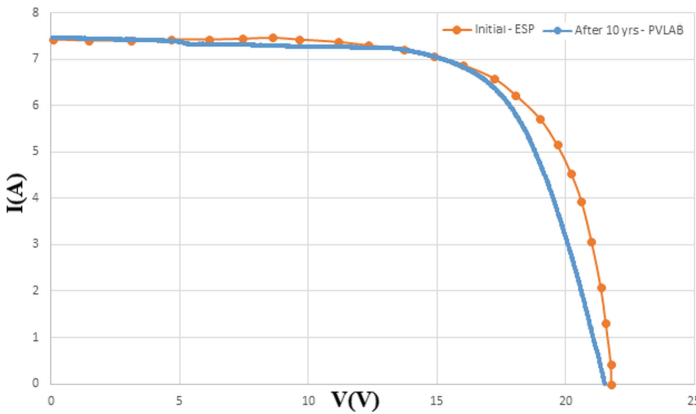
Fig. 9. I-V characteristics of monocrystalline module (B).

After 10 years of operation in hot and semi-arid climatic conditions, the PV module I-V curve were measured using pulsed solar simulator the comparison between measurements made initially and after exposition (Fig. 9) showed that, the short circuit current (I_{SC}) and the open circuit voltage (U_{OC}) did not change too much. However, the trend of the IV curve obtained after the operation years shows a slight decrease in the maximum power. In the literature [6, 7], such a change on curve IV is due to an increase in the series resistance R_S . This variation in resistance mainly affects the PV module operating voltage.

The comparison between the performance characteristics initially measured and that after the years of operation clearly shows that the nominal (I_{MPP}) and short-circuit (I_{SC}) current have not been affected. However, even if the variation is not too great, among all the parameters, voltage was the only electrical characteristic that deteriorated. The open-circuit voltage goes from 21.765 V to 21.5 V. The maximum power voltage has experienced the greatest variation, with an initial value equal to 17.3 V, it becomes 16.73 V, i.e. an absolute reduction of 0.6 V (Table 4).

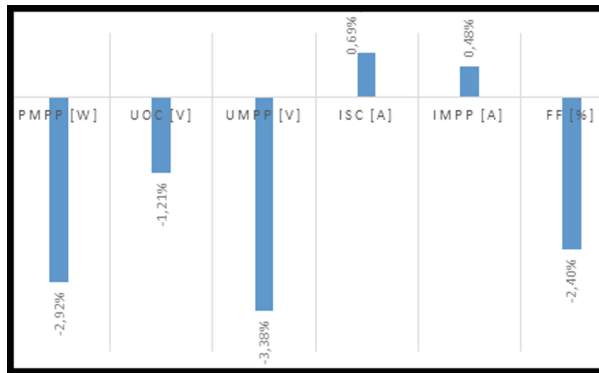
Fig. 10. Performance degradation of module B.

The results obtained are summarized in Fig. 10. As expected with series resistance increase visible in the IV curve (Fig. 10), the maximum power voltage is the most affected characteristic, its absolute deterioration is -3.38% . Indeed, for a PV module exposed for almost 10 years, a degradation of only -2.92% of the maximum power is a good compatibility sign of this technology within the climate. However, it is always necessary to evaluate the different types of defects that affected the module to verify the material defects caused by the tropical climate. The Fill factor (FF) degradation is mainly due to the degradation nominal voltage degradation.

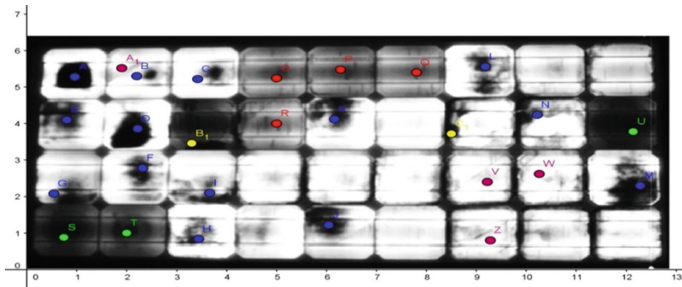
Fig. 11. Module A EL image with $I = I_{SC}$. (Color figure online)

Defects in the material of the cell, micro-cracks, broken metallization, shunts, inactive regions are detected via Electroluminescence imaging in Fig. 11. This EL used to identify the defects is made under I_{SC} current. The fault types present in the modules are identified with different colors.

- 15 cells (blue) have visual impairments such as discoloration and corrosion identified during visual inspection. These types of defects are directly related to climatic conditions mainly humidity.

- 2 cells with breakages which often occur during transport, packaging or installation of the modules. These types of mechanical damage are caused by insufficient packaging and vibration/shock.

- 4 cells with casting defects better known by the Contact finger interruptions. These types of defects are usually caused by insufficient screen printing during manufacturing. Because of their significant presence and non-uniform distribution, their remarkable effects on cells productivity are clearly evident.

- 4 other cells have microcracks, these types of defects such as breaks often occur during transport of the modules. The variation of the intrinsic manufacturing process can also be the cause of cells microcracks. But they are less serious and mostly invisible during visual inspection. However, they may cause deterioration in performance after several years of operation.

- 3 cells have unspecified dark areas. Several assumptions can be made about the origin of the dark shade: it may come from a local modification of the efficiency favoring non-radiative recombination of the charges, modification of optical properties of this zone and therefore the number of photons collected by the detector, or a modification of the contact resistance.

In summary (Table 6), most of the defects identified on the module are due to the effects of the exposure climate conditions. 14 cells suffer from material degradation due mainly to contact of water with the cells. This water often present in moist air causes discoloration and corrosion. Given the climatic conditions of the operating site, it is evident that the high humidity of the hot location has effects on the cells. Indeed, Dakar is a very wet place with an annual average of 78.6%.

The rest of the defects are for the most part mechanical. 6 cells have either microcracks or breaks due to poor handling during transport or laying. Manufacturing defects are fairly present. 4 cells with metallic hits severely affected are identified. 3 other cells have unidentified defects but often come from manufacturing.

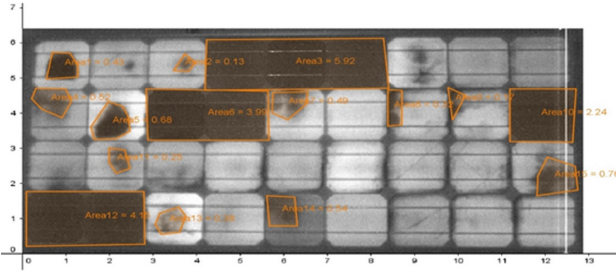
Fig. 12. Module A EL image with $I = 10\% I_{SC}$.

According to the chosen scale on the Fig. 12, the panel's total area is 75 cm². The fifteen (15) degraded areas evaluation gives a total dark surface of 20.97 cm² affected by the different types of defects cited above. Thus, 27.96% of the module's surface has been deteriorated. This materiel degradation of the surface led to a degradation of -5.35% in the maximum power (P_{MPP}). Then, the degradation of 1% of the surface causes a reduction of about 2% in the maximum power. Nevertheless, the black areas should not be interpreted as a totally zero emission, a black zone emits very little compared to the rest of the cell. And this is what causes electrical mismatches and reduce the I_{SC} .

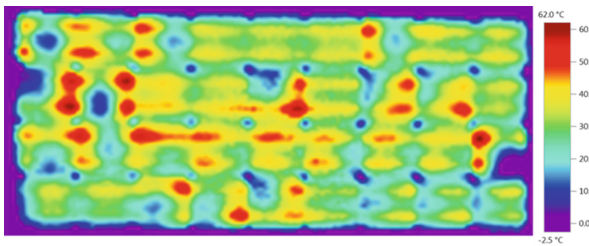
Fig. 13. Module A IR Image

In a normal PV module, all the cells are considered identical. For a defect less module, the temperature distribution is homogeneous because all the cells have the same characteristics. Thus, PV module thermography image visualization is a very useful tool to state a PV module. Infrared imagery specifically identifies hot spots and cold spots. Hot spots indicate a decline in productivity in these areas, which dissipates the surplus current from other parts as heat. This occurs when the cell is totally or partially shaded, fractured or electrically defective. The severity of this degradation is directly related the cell's the temperature. The cold zones highlight the visual degradations. The areas affected by these types of degradation act as insulators. The monocrystalline module IR image in Fig. 13 shows a striking thermal disparity. Temperatures range from 0 °C to 62 °C. Several hot points or surfaces are visible; Which proves that the different types of degradations identified previously decrease the electrical current. The cold parts identified represent the visual defects highlighted in the EL image. This photovoltaic module exposed for about ten (10) years shows a great thermal inhomogeneity, meaning an advanced electrical mismatch. This justifies the significant I_{SC} degradation and the decrease of the I_{MPP} .

The IR image for the monocrystalline module well justifies extensive degradation of the short circuit current and maximum power. The Module I_{sc} mismatch clear shown in the thermography with many hot spots means that those parts can no more produce the short circuit current. So, the damage previously identified as corrosion and discoloration decreased the electrical output of several cells. Indeed, in the IR image analysis with a current equal to I_{SC} shows a large rise in temperature which reached $60\text{ }^{\circ}\text{C}$. This means that a big part of the module no longer produces enough power and transforms the surplus current coming from the healthy cells into heat. For the poly, the IR image shows that productivity is not too affected. The temperature distribution is almost homogeneous. We can then say that; the important mechanicals defects identified with the EL image do not affect too much the cells' production. Thus, by comparing the analyzes of the IR and EL images of the two modules it can be concluded that the defects caused by the climate on the mono module affect much more the production than the numerous mechanical defects on the poly.

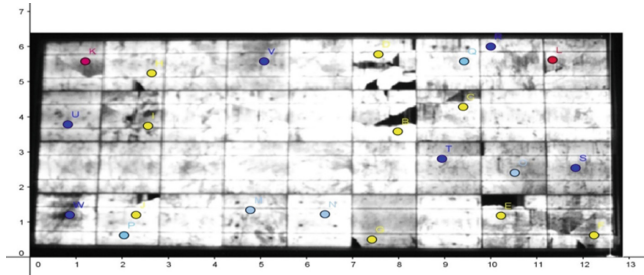
Fig. 14. Module B EL image with $I = I_{SC}$.

The EL image for polycrystalline module was realized under the same conditions as the previous analyzed monocrystalline. For defects identification, the EL image used is realized under the short circuit current (I_{SC}) with different colors pointing fingers at the types of degradation present in the module (Fig. 14).

- 9 cells of the polycrystalline module experienced fairly extensive breaks which isolated the broken cell parts.
- 6 cells have visual defects due to the effects of the environment. During visual inspection, delamination of PV module's encapsulat has been identified. This probably justifies the presence of these dark surfaces indicating visual degradation.
- 5 cells have localized shunts. This type of defects is generally due to problems during cell's manufacturing (a particle, an anomaly in growth, etc.). It may also be a consequence of an external event such as electrostatic discharge or mechanical stress.
- 2 cells have micro cracks which elongated the list of mechanical defects.

For the polycrystalline module, mechanical defects due to physical constraints are the most present defects. Nine (9) cells in total have breakages often very advanced, and 2 others have micro cracks (Table 7).

Concerning the material or visual defects often due to the effect of the environment, they are present on 6 cells which are not nevertheless very affected. Indeed, since a polycrystalline module is not homogeneous in nature, it is sometimes difficult to identify the photoelectric effect. Manufacturing defects also are still present with many localized shunts.

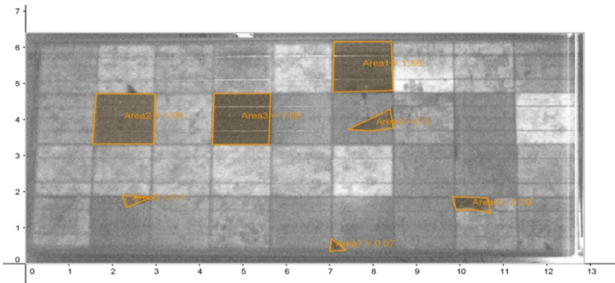
Fig. 15. Module B EL image with $I = 10\% I_{SC}$.

Using the same software, and with the EL image of the polycrystalline at $I = I_{SC}$, the results obtained show that the isolated surface is not very important. Seven (7) zones are isolated, representing a total area of 6.38 cm^2 . So only 8.5% of the module's surface was severely affected, causing a degradation of -2.92% of the maximum power (P_{MPP}). Thus 3.5% of the power decreased to 1% of affected area.

However, it has always been pointed out that these isolated areas represent the consequences of all the defects identified. Similarly, they are not totally eliminated from the module, even if their participation is weak they slightly participate in the functioning of the module (Fig. 15).

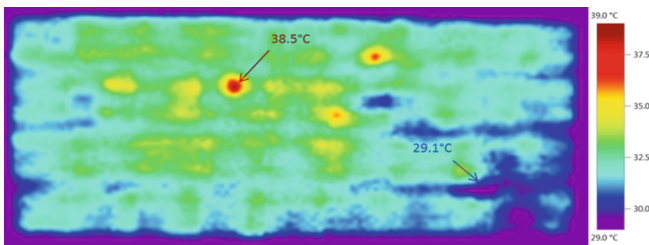
Fig. 16. Module B IR Image

The IR image of the polycrystalline module shows a more homogeneous thermal distribution compared to the mono. Temperatures range from 29 to about $39 \text{ }^\circ\text{C}$. The maximum temperature is not then so critical because it is less than the NOCT of $45 \text{ }^\circ\text{C}$. the biggest part of the surface has a temperature of about $30 \text{ }^\circ\text{C}$. Apart from 3 hot spots identified and some cold areas, the thermal disparity is not significant enough. Thus, the passage of the electric current is not too disturbed hence the low degradation of the current compared to the initial characteristics (Fig. 16).
