# Analysis of Slum Settlements on Livable Houses in Belawan Bahari Village, Medan

**Abstract.** The rising demand for housing, in contrast to the limited availability of land, has resulted in the uncontrolled expansion of residential areas. This phenomenon contributes to the emergence of slum settlements, as observed in Belawan Bahari Village, Medan. Slum areas are typically characterized by deteriorating environmental quality, which is largely attributed to the prevalence of substandard housing and unsanitary living conditions. In light of these challenges, it is essential to conduct an evaluation of the residential environment's feasibility, with a particular focus on the adequacy of housing in Neighborhood VIII of Belawan Bahari Village, Medan. The assessment of housing suitability encompasses the structural integrity of buildings, construction quality, and spatial arrangements. Subsequently, the analysis is carried out using a qualitative descriptive approach, employing weighting and scoring methods to classify the results into three categories: very good, good, and poor.

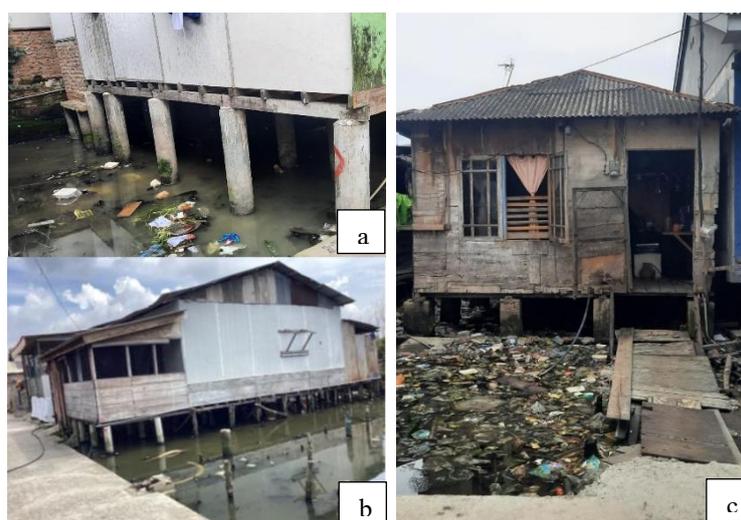
**Fig 2.** House Structure and Construction (a. Stilt house with concrete pile foundation; b. Wooden board wall structure; c. Access to the interior of the house)

Belawan Bahari Subdistrict is located on the coastline and is highly prone to tidal flooding. The phenomenon of tidal flooding, which is the rise of sea water onto land, has a significant damaging impact on residents' houses, [8]. In addition to tidal flooding that leaves waterlogged areas, residents also experience waterlogging due to sea water rising through the estuaries of the Belawan and Deli Rivers. This condition exacerbates the waterlogging, causing the ground surface to remain wet. Stilt houses are a solution for residents' comfort and convenience. Most people use stilt houses with concrete or wooden foundations, many of which are now beginning to become porous and decayed. Observations show that the foundation conditions do not yet meet the structural durability criteria, **Figure 2a**.

The stilt house design with a wooden plank floor extending the column posts is characteristic of coastal stilt houses. The flooring materials consist of wooden planks and plywood. The wooden boards are laid flat and supported by beams underneath. The wood material, according to analysis, shows signs of deterioration in the floor structure of some houses due to inadequate maintenance. The damage to the floor poses a threat to the safety of the residents.

This issue also occurs in the wall structure. The wall materials used are wooden boards arranged vertically and horizontally, along with plywood used as partitions between rooms inside the house. Some houses even use plywood as exterior wall covering, as shown in **Figure 2b**. The choice of inappropriate materials leads to easy damage to the building. Based on the

assessment results, the wall structure does not meet the comfort and safety standards for the occupants within the house (**Figure 2c**).

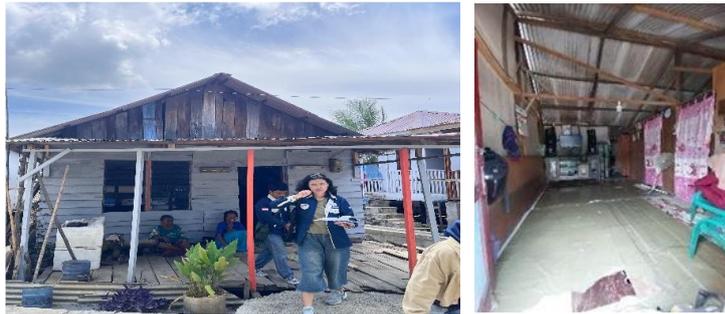
**Fig 3.** Roof structure model (gable roof shape, and interior condition of houses without ceilings)

The roof structure uses zinc and corrugated asbestos materials. About 90% of the roofs are gable-type and generally do not have ceilings. This roof design is easy and inexpensive to maintain. Field conditions indicate that some houses experience rotting and corrosion on the zinc roofs, caused by relatively high salinity levels, **Figure 3**.

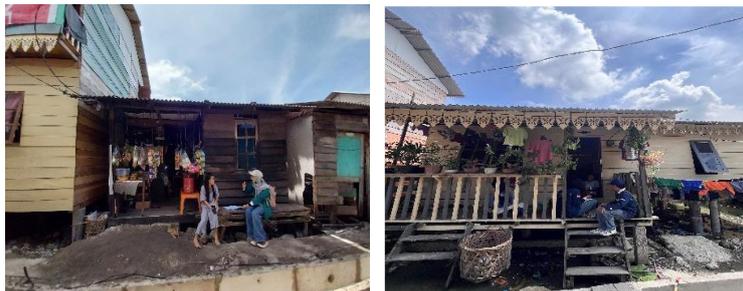
Fig 4. Building appearance dynamics

Lighting system consists of natural and artificial lighting. Lighting is needed inside the house to see and analyze objects visually. The involvement of light intensity will affect our vision of an object, [12]. The allowed standard for openings on wall surfaces according to Greenship is a minimum of 30% of the room's floor area, [13]. The lighting analysis shows that the condition of openings on the house wall surfaces does not meet the established standard. This is caused by the very narrow distance between houses, which ranges from 1 m to 0.5 m, **Figure 4**.
