Visual Inspection Of Photovoltaic Modules Deployed In A 15 KwP Off-Grid Solar Power System At Hoineno Village

Politeknik Negeri Kupang

Abstract. Photovoltaic (PV) modules deployed outdoor are exposed to various environmental conditions which can contribute to degrade their power output. Visual inspection is a well known as an initial method commonly applied to assess degradation modes of PV modules. By applying the method, it was found that the modules installed on the 15 kWp off-grid solar power system at Hoineno village experienced several degradation modes such as snail trails, microcracks, soiling, discoloration, and corrosion. Except soiling factor, the type of degradation is likely attributed to the high temperature and humidity in the village. The effect of dust can be eliminated by performing a cleaning procedure. By doing that, economic losses and permanent degradation on PV modules can be avoided.

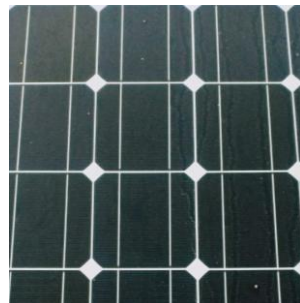
Discolouration is the most common type of degradation introduced by solar modules that have been operating for years in the field. Visual inspection results of Hoineno system are shown in Figure 2. This defect degraded the module's performance as it reduced the intensity of sunlight reaching the solar cells. Studies showed that discoloration could be caused by external factors, such as changes in humidity and temperature, and internal factors, namely poor quality of encapsulants.

Figure 2. Discoloration of PV modules at Hoineno

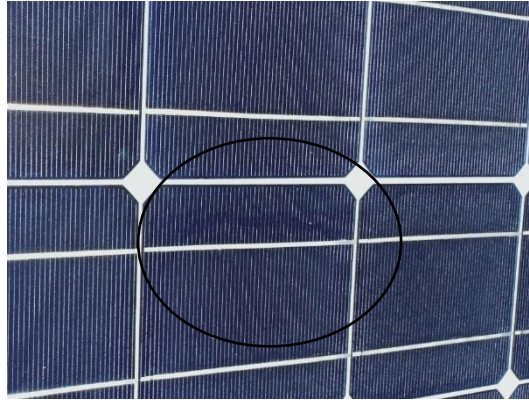
This degradation is classified as a new phenomenon characterized by discolouring of the silver grids across the surface of the cell or along the edge of the cell (Figure 3). In some cases, snail trails appear on modules that have only been installed for several months [8]. Other studies also found that snail trails growing on the cells are very slow [9].

Figure 3. Snail trails of a PV module at the Hoineno off-grid system

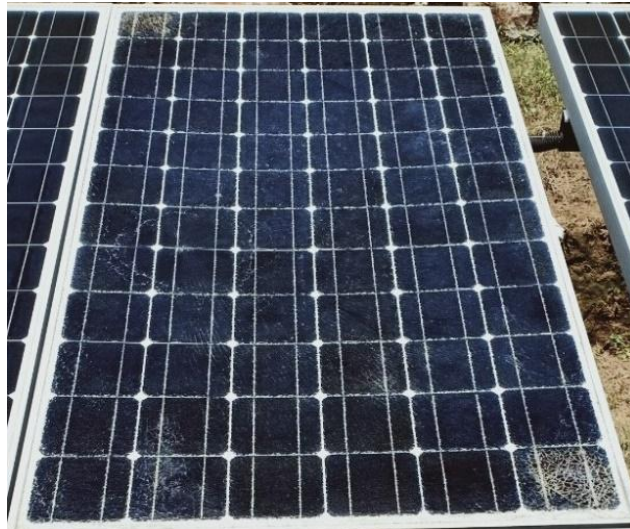
Microcracks can occur due to the manual soldering process during manufacturing where the cell is subjected to mechanical pressure and heat that is too high. Under further pressure, after years in the field, the cracks can be larger and clearer for visual detection. Cracking solar cells can reduce module output. Photograph of microcracks of a PV module at Hoineno system is shown in Figure 4.

Figure 4. Microcracks of a PV module at Hoineno system

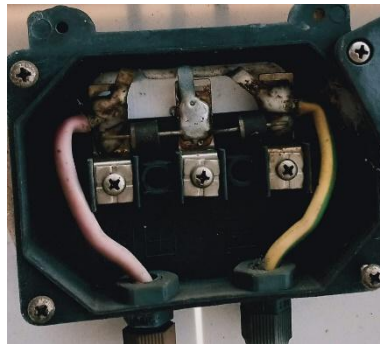
Junction box is a terminal box located on the back of solar panel that are used as a place to connect several PV modules to be a string. A good junction box must be tightly closed so that water and other materials can not enter. keep corrosion in the terminal to a minimum, because it does not include incoming water. Visual inspection results show that the junction boxes of some modules are not tightly closed. As a result, corrosion occurs in the PV electrical terminals as shown in Figure 5.

Figure 5. Corrosion on junction box of a module at Hoineno

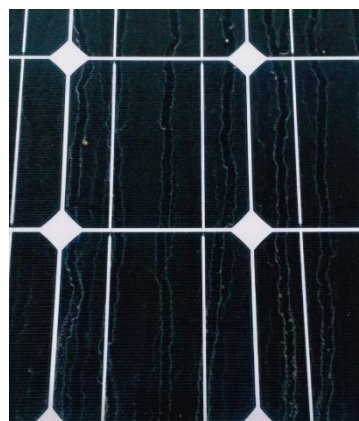
PV modules installed outdoor are exposed to various environmental conditions. One of the environmental factors that causes performance degradation is soiling. The PV modules deployed at Hoineno system also experienced the same situation. Soiling/dust attached on the modules is generated by wind and human activities around area of the modules. As shown in Figure 6, the modules have not yet been cleaned by the operator of Hoineno system. This condition, understandable, reduces the electric power generated by the modules. Dust that adheres to the surface of the modules prevents or reduces the intensity of solar irradiation that should be received by solar cells of the modules. If this is left unchecked, from time to time hot spots will arise which can cause permanent damage on the modules [10].

Figure 6. Soiling degradation of a PV module at Hoineno system
