The Impact of Snail Trails and Cracks to Energy Output of Photovoltaic Modules At Lotas Off-Grid PV System

Rusman Sinaga¹, Julius A. Tanesab², Marthen Dangu Elu Beily³
{rusman_ipb99@apps.ipb.ac.id¹, julius_halan@pnk.ac.id², marthen.baily@yahoo.co.id³}

Electrical Engineering Department, State Polytechnic of Kupang,
Jalan Adisucipto Kupang, Indonesia¹²³

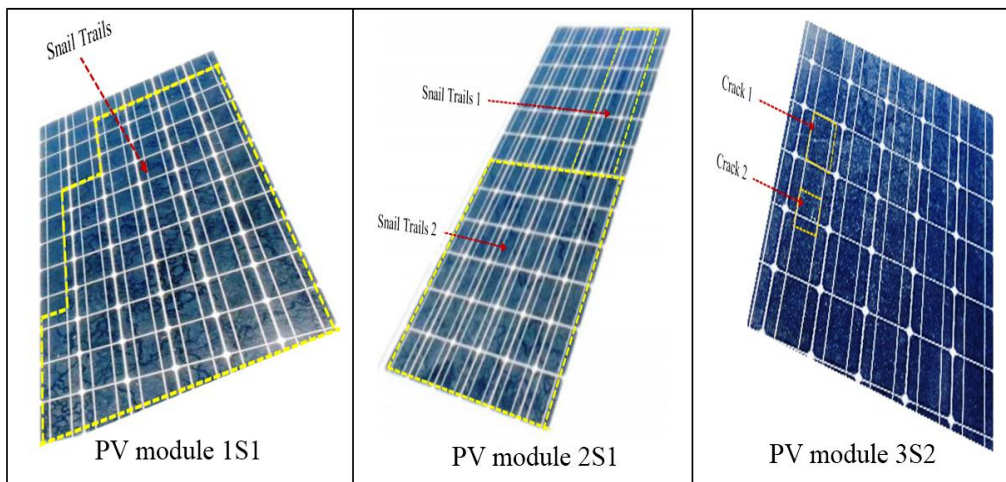
The results of observation through visual inspection show that the Percentage of Degradation (PoD) of PV Module 1 in string 1 is caused the snail trail of 84.60%, PV module 2 in string 1 is also caused by snail trail of 66.01%, while PV module 3 string 2 is caused the crack of 3.98%. The degradation of the PV module is presented in Figures 3, while the Percentage of Degradation (PoD) of PV Module are presented in Table 2.

Fig. 3. The snail trail and crack degradation of the PV modules

Nr	String	PV Module	ToD	AD (m ²)	PoD (%)
1	1	1	Snail Trail	1.08000	84.60%
2	1	2	Snail Trail 1	0.20025	15.69%
3			Snail Trail 2	0.64240	50.32%
4	2	3	Crack 1	0.02400	1.88%
5			Crack 2	0.02684	2.10%

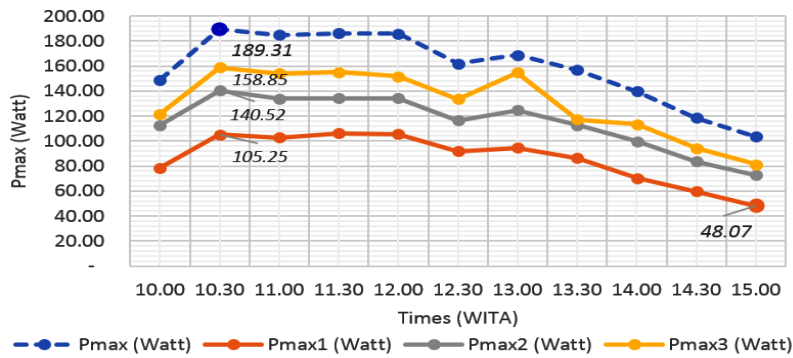
The ROC test results of PV module (200 Wp) on August 14, 2019, for 6 hours showed that the new PV module (Pmax) had the maximum power of 189.31 Watt. Meanwhile the old PV module, for maximum power of PV module after degradation by snail trails in PV module 1 in string 1 (Pmax1) of 105.25 Watt and PV module 2 on string 1 (Pmax2) was 140.52 Watt. The maximum power of the PV module after degradation by a crack in PV module 3 in string 2 (Pmax3) was 158.85 Watt. Maximum power comparison curve before and after the snail trail and crack degradation through the ROC test are presented in Figure 4 and I-V curves of PV module before and after snail trail and crack degradation are presented in Figure 5.

Fig. 4. Pmax curves before and after snail trail and crack degradation

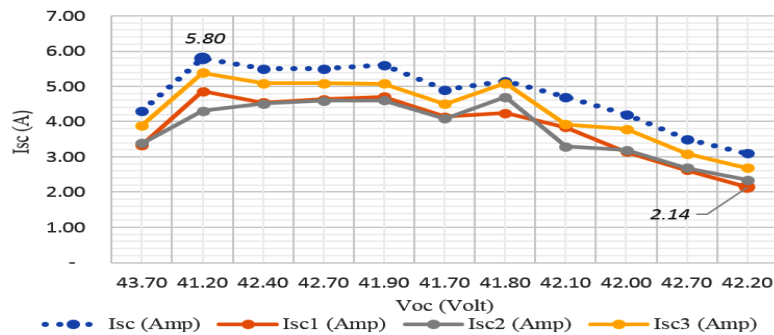
Fig. 5. I-V curves of PV modules before and after snail trail and crack degradation
