Investigating Structural Cracks for Infrastructure: Case Study of Anonymous Hospital, in Zimbabwe

Abstract. The main objective of the research was to investigate the structural cracks for infrastructure at the anonymous Hospital in Zimbabwe and recommend the appropriate engineering solutions to the structural problems. Desk studies, geotechnical and materials investigations and investigations of the structural designs for the existing infrastructure was conducted. Geotechnical tests included sieve analysis, soil indicator, shear strength, direct cone penetrometer, chemical dispersive and California bearing ratio tests. Most of the cracks were structural cracks. The foundation depth was determined as 1.5 m for a bearing capacity more than 100 kPa. The causes of cracks included use of substandard bricks and construction materials, thick mortar and inadequate foundation depth. The dispersive test also proved that the soils are sodic in nature. It is recommended to use reinforced strip foundations and deep foundations when constructing infrastructure at the site. Heavy duty concrete foundation underpinning is recommended for the existing buildings.

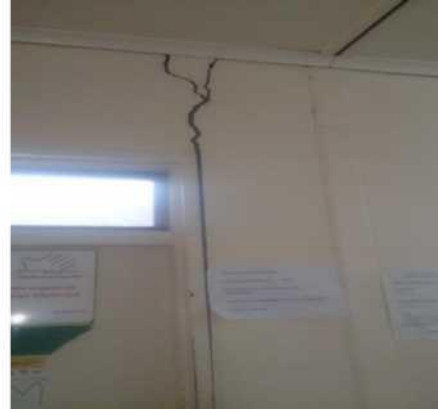
Fig. 3. Vertical crack on another building

The vertical wall varied from 1 m to 5 m in length and 0.5 mm to 45 mm in width. Externally applied loads cause horizontal cracks. Settlement problems and heaving cause vertical cracks which are wider at the top and bottom. Table 1 shows the results obtained during fieldwork at the anonymous Hospital. The design limits according to BS5628 [16].

The crack widths exceeded the design limits so these are structural cracks which need to be repaired urgently, from [17] these are more than 25 mm. Geotechnical and analytical approaches were employed in the collection of the data.

From [19] for cracks up to 1 mm the damage is only experienced to the wall finishes and the treatment can be done by normal decoration. Cracks with a width from 1 to 5mm can easily be filled. Cracks from 5-15 mm require some opening up and can be patched by a mason, some bricks need to be replaced. For cracks from 15-25 mm this is extensive damage and requires breaking out and replacing sections of the wall especially over doors and windows. The walls will be leaning or bulging. For cracks more than 25 mm this is structural damage that requires a major repair job involving partial or complete rebuilding. If cracking on concrete is due to drying shrinkage the crack will stabilize, if due to foundation settlement the settlement problem must be corrected [9]. For cracks less than 1 mm bonding by injection of epoxy is recommended. Routing and sealing of cracks can be used whereby the crack is enlarged along its exposed face and a joint sealer is used to fill and seal the crack [9]. The other methods recommended include near-surface reinforcing and pinning, additional reinforcement, drilling and plugging, polymer impregnation, grouting and crack arrest [9].

It is recommended to use deep foundations, reinforced strip foundations, allowing for weep holes where terrain is highly differential, foundation underpinning and stabilising the base foundation when constructing buildings at the Anonymous hospital. It is also recommended that the structures with the failures recorded in this paper be treated with caution and repaired as some of the structural failures are far beyond serviceability failures. Using the findings from this paper, such as the repair strategies, similar studies can be done on other buildings experiencing structural failures.
