Failure Analysis and Research on the Explosion and Leakage of the Secondary Superheater Tube in a Power Plant

Inner Mongolia Electric Power Research Institute

Abstract. During the operation of boiler 1, the secondary superheater pipe elbow section failed due to explosion and leakage. In order to find out the cause of the explosion and leakage of the elbow section of the secondary superheater tube, a comprehensive test analysis was carried out on the failure cause of the elbow section of the secondary superheater tube with the appearance analysis, chemical composition analysis, microstructure detection and mechanical property detection. The results show that the leakage of the elbow section of the secondary superheater tube is due to the long-term overheating of the elbow section of the secondary superheater tube during the operation process, resulting in a serious reduction of spheroidization strength, which was not enough to withstand the leakage caused by the internal medium pressure, and the leakage of the adjacent superheater tube was caused by the leakage steam blowing away the adjacent superheater tube.

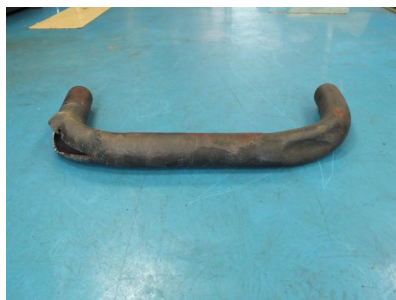
Observe the macro morphology of the secondary superheater elbow section, as shown in Figure 1-2. The explosion of the secondary superheater pipe was located at the elbow section, with a length of about 130mm, and the pipe diameter had no obvious expansion; The edge of the blast hole was rough and blunt, and there were traces of being blown away by steam. The pipe wall had no obvious thinning. The oxide skin of the outer wall near the blast hole was in the shape of "old tree bark", and there were no defects such as mechanical damage and corrosion damage. It had the typical characteristics of long-term overheating tube explosion.

Figure 1. Macromorphology of blow-out pipe

From the macroscopic morphology analysis, the explosion of the secondary superheater pipe was located in the elbow section, and the pipe diameter had no obvious expansion; The edge of the blast hole was rough and blunt, the pipe wall was not significantly thinned, the oxide skin of the outer wall near the blast hole was in the shape of "old tree bark", and no defects such as mechanical damage and corrosion damage were found, which had the typical characteristics of long-term overheating tube explosion^[5-7].

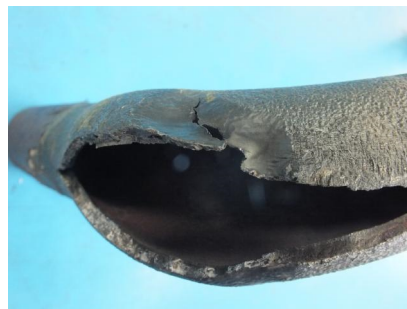
Figure 2. Crater morphology

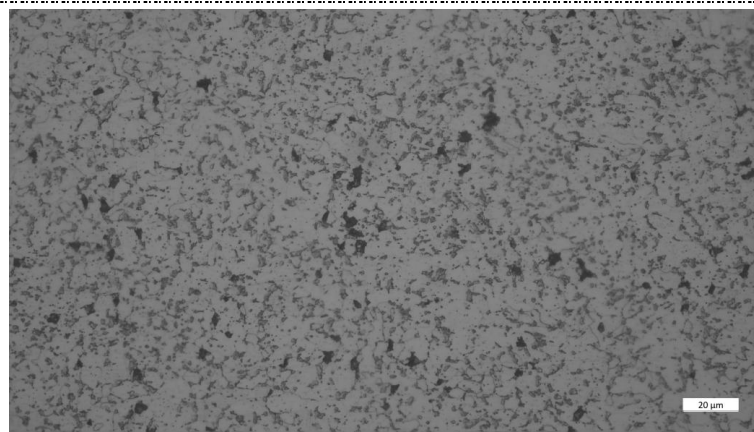
The microstructure of the bend section of the secondary superheater tube was analyzed, as shown in Figure 3-4. The metallographic structure at the blast hole had been seriously aged, its structure was ferrite+granular carbide, the bainite morphology had completely disappeared, the carbide had gathered and grown up to be granular, the coarse carbide was distributed on the grain boundary in spherical and chain shape, and there were a large number of grain boundary creep holes and creep cracks. The metallographic structure on the opposite side of the crater was ferrite+granular carbide.

Figure 3. Intermittent metallographic structure at the crack.

According to the analysis of metallographic structure, the metallographic structure at the blast hole had been seriously aged, its structure was ferrite+granular carbide, the bainite morphology had completely disappeared, the carbide had gathered and grown up to be granular, the coarse carbide was distributed on the grain boundary in spherical and chain shape, and there were a large number of grain boundary creep holes and creep cracks. The metallographic structure on the opposite side of the crater was ferrite+granular carbide^[8-10].

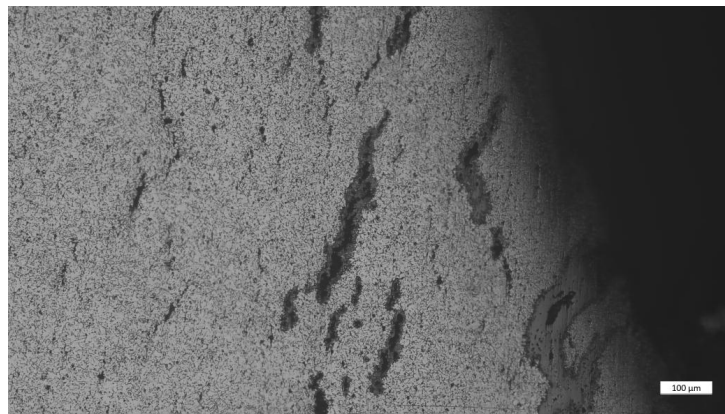
Figure 4. Creep holes and cracks
