Analysis of Soil Movement Hazards Trigger on Main Road Segment Denpasar-Singaraja in Baturiti District, Tabanan

I Nengah Sinarta*, A. A Gede Sumanjaya, I Wayan Ariana Basoka
{inengahsinarta@gmail.com}

Departement of Engineering and Planning Faculty, Universitas Warmadewa, Denpasar, Bali, Indonesia

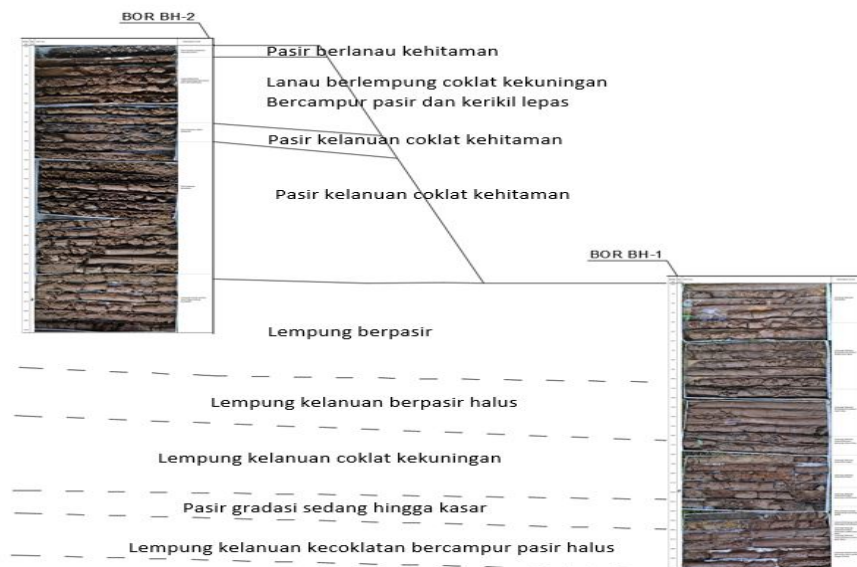
Figure 2. Data Drill

Based on the drill data, it can be seen the description of the soil in Figure 2. as follows: at depth of 0.00 from the topsoil to a depth of 1.00 meters in the form of blackish silty sand mixed with gravel. Then from a depth of 1.00 meters to 8.00 meters in yellowish-brown loamy silt mixed with sand and loose gravel. Then from a depth of 8.00 meters to 10.00 meters in the form of blackish-brown silty sand. Then from a depth of 10.00 meters to 24.00 meters in the form of brownish silty sand. Then from a depth of 24.00 meters to 30.00 meters in sandy loam with acceptable to medium brown gradations. The groundwater level was found at a depth of -26.80 meters.

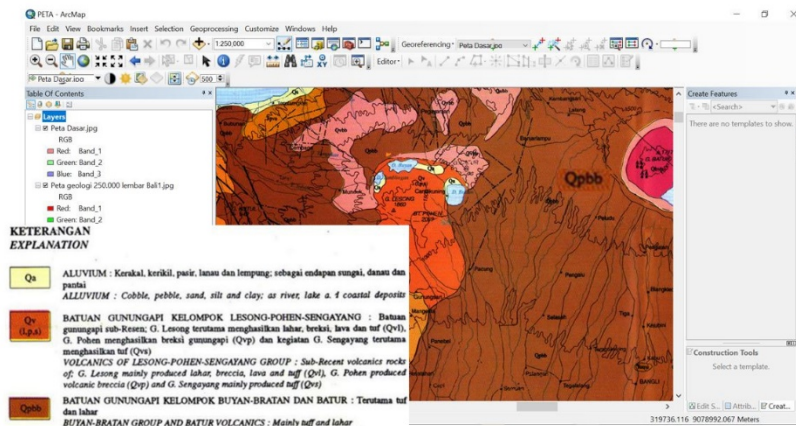
Figure 3. Geological Map of the Research Area

The Geological Conditions based on geological map sheets of Bali Nusa Tenggara [10], the analysis was carried out with the help of Arc-GIS software to help overlay as shown in Figure 3, where the geological conditions at the project location are in mountainous areas, there are two rock formations, namely; extruded rock from Mount Batukaru and volcanic rock from the sub recent cones of Mount Pohen, Mount Sangiang, and Mount Lesong. The constituent rocks are Qv rocks which are volcanic rocks of the Lesong-Pohen Sengayang group, and there are Qpbb rocks which are volcanic rocks of the Buyan-Bratan and Batur groups, especially tuff and lava; there are no geological structures in the form of faults or faults in this area.
