Occupational Risk Assessment Using the Failure Mode and Effect Analysis (FMEA) Method in the Production Room of Bearing Industry

Abstract. PT X is an industry engaged in the manufacturing of bearings. This study aims to conduct an occupational risk assessment in the production room of PT X using failure mode and effect analysis (FMEA). The results of risk assessment in 5 working areas in the Production Room resulted in the risk priority number (RPN) value of the raw material storage area were 687, combustion area (30), assembly area (1481), packaging area (296), and the delivery area (432). RPN calculation on FMEA showed that the assembly area has the most significant RPN value, so it was prioritized for risk control measures. The controlling efforts were providing sticks and machine protective covers, replacing damaged button covers, machine operator training, improving standard operating procedures (SOP), and others. Therefore, controlling the risk was expected to reduce the potential risk of a work accident.

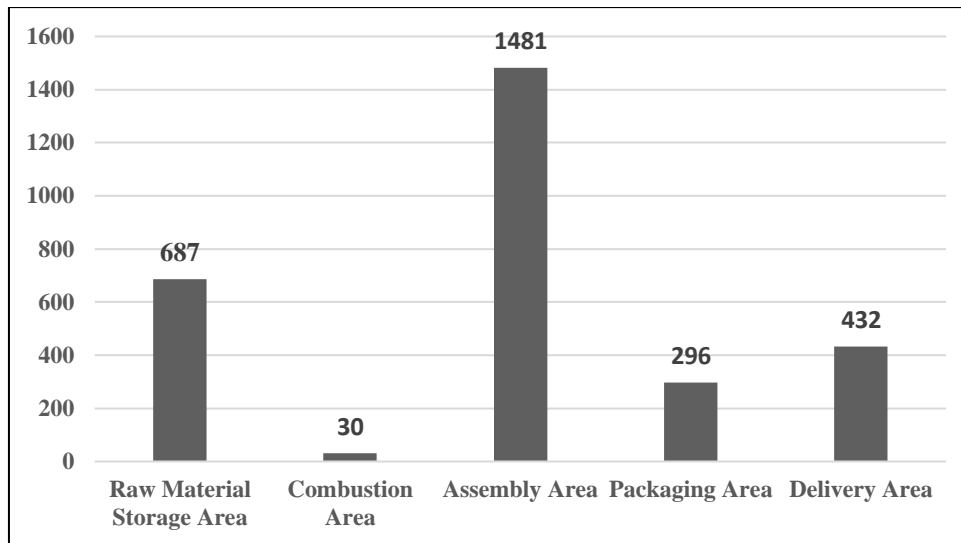
Fig 2. Comparison of total RPN value in all areas

Figure 2 shows that the assembly area had the highest RPN of 1481. The assembly area was a selected work area that was prioritized to be controlled because it had the most significant RPN. In this area, nine work accidents have occurred. There were suggestions to reduce workplace accidents in the assembly area by preparing backup tools in the form of sticks and protective covers on the machine so that work accidents do not occur when picking up the stuck ring. Replace the damaged machine button cover so that there are no sharp parts from the engine button cover that can cause injury to workers [9]. Provide machine operators with regular training and socializing related to work safety for three months so that they do not press the machine button incorrectly. Additionally, employing anti-slip coatings, having backups, and regularly inspecting safety shoes can help maintain a comfortable and safe workplace environment [10]. In reducing work accidents caused by high engine noise, socialization and training related to personal protective equipment (PPE) can be carried out. Socialization and training related to PPE can create awareness regarding the use of PPE to avoid work accidents [11]. The solution that can be done to reduce work accidents due to poisoning is to disseminate clear work procedures related to the containment or use of chemicals. In addition, to reduce work accidents due to falling assembly room ceilings, it can be done by replacing the ceiling with a new one. According to the Minister of Public Works Regulation Number 24 of 2008 concerning Guidelines for Building Care and Maintenance [12], it is stated that the ceiling on a building may be damaged if it has been used for approximately ten years. In addition, according to Rahmah (2017) [13], making special boxes to store cables located in areas that are not passed by employees or placed on walls can reduce the risk of work accidents due to electric shock. The final solution that can reduce work accidents due to transportation of non-ergonomic goods can be done by educating workers regarding ergonomics. Education related to ergonomics has been shown to reduce low back pain complaints [14]. Table 10 shows the recommended action to tackle the potential failure in Assembly Area.

Table 10. Recommended Action as a Risk Control Measure in the Assembly Area

Potential Failure Mode	Recommended Action
Worker injured while picking up ring stuck in machine	Provide tools (sticks) to take the ring, install the engine protective cover, and install K3 Signs.
Workers are injured when operating machines	Replace the damaged engine button cover.
Error pressing the engine button	Conduct regular training for machine operators and install OHS Signs.
Workers fall in the work area	Install anti-slip on the floor.
	Provide spare safety shoes and check worker safety shoes
Workers exposed to high levels of noise	Conduct socialization and training related to personal protective equipment
Workers exposed to chemicals	Develop clear work procedures related to the containment & use of chemicals in the assembly room and install K3 Signs.
The ceiling in the assembly room is falling	Replace the damaged ceiling with a new ceiling.
Workers are electrocuted while operating machinery	Arrange the laying of electrical cables specifically.

Items are not handled ergonomically	Organizing regular ergonomics training for workers and installing OHS Signs related to ergonomics.
