Investigation of Diode Holder Plate Damage on ATR 72 Type Aircraft for the 2022-2023 Period

Keywords: Component Investigation, AC Generator, Diode Holder Plate

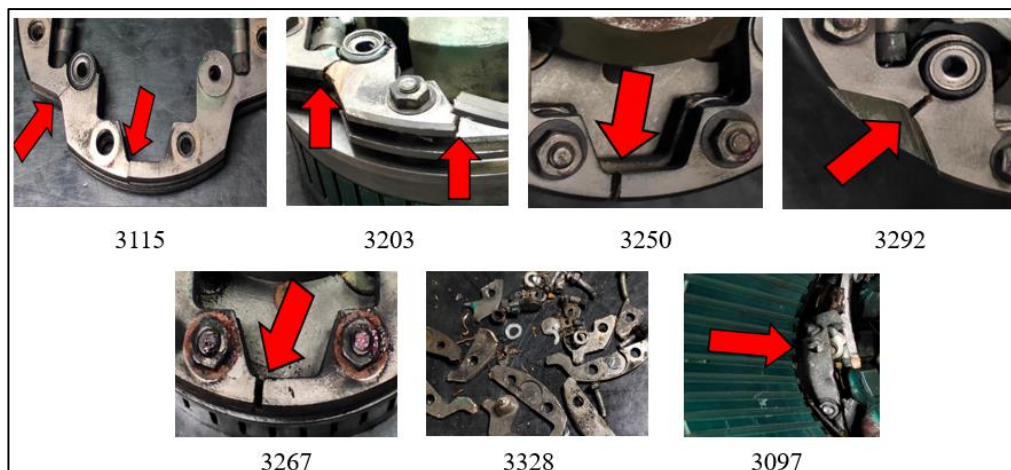
The diode holder plate can also be damaged due to mechanical damage such as impact or excessive vibration during aircraft operation. Like other electronic components, diode holder plates have a limited lifespan [6]. Once they have passed their lifespan, they may become unreliable and need to be replaced. Repairs or replacement of the diode holder plate on the ATR 72 aircraft AC generator must be carried out by a technician experienced in aircraft maintenance. This is important to ensure that the aircraft's electrical systems function properly and safely [7]. In addition, good preventive maintenance and regular monitoring are the keys to preventing damage to the diode holder plate and other components on the aircraft AC generator. This will help maintain aircraft reliability and performance in optimal conditions. Below we will explain several diode plate holders according to the serial number on the ATR-72 aircraft AC generator in Figure 1.

Fig. 1. Several diode plate holders according to the serial number on the ATR-72 aircraft AC generator (source: author)

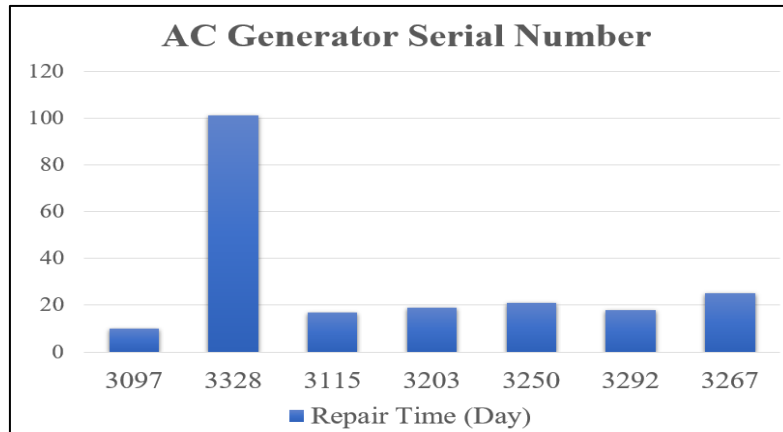
Based on what is explained in Table 1, it turns out that there are components that have quite a long repair duration. Therefore, a diagnosis is needed in this case, so it is important to remember that long-term damage will have an adverse impact. The following will explain the repair period in Figure 2.

Fig. 2. Repair time based on AC generator serial number (source: author).

In this research, the AC generator SN 3328 took the longest to repair because it took 101 days. In order to have a good culture in terms of engine repairs, it is better if the engine does not need to be overhauled or if it is required to be overhauled, just carry out more diagnostics so that it doesn't take time to work, in fact, the time is faster when the engine is not overhauled but only repaired, for example on AC generator components. SN 3203 and 3292 which are quite short repairs. All components have their own repair schedule, which means they can be predicted according to their lifetime. However, it is very unfortunate that this is not always appropriate, even though some parts experience unscheduled replacement, such as AC generators SN 3203 and 3292.
