Digitization of civil architecture objects during wartime using photogrammetry: A case study of Sumy State University

I. Tytarenko¹ and I. Pavlenko^{2,*}

METHODS: A photogrammetric technique was employed to create an accurate 3D model of Campus K-2 of Sumy State University, destroyed by Russian missiles on April 13, 2025, in Sumy, Ukraine. A comprehensive approach for involving photogrammetric reconstruction, texture processing, and building information modeling (BIM) integration was described. The research also outlines the challenges of restoring during wartime, discusses data acquisition and processing workflow, and evaluates the effectiveness of low-cost equipment and open-source software in achieving high-quality results.

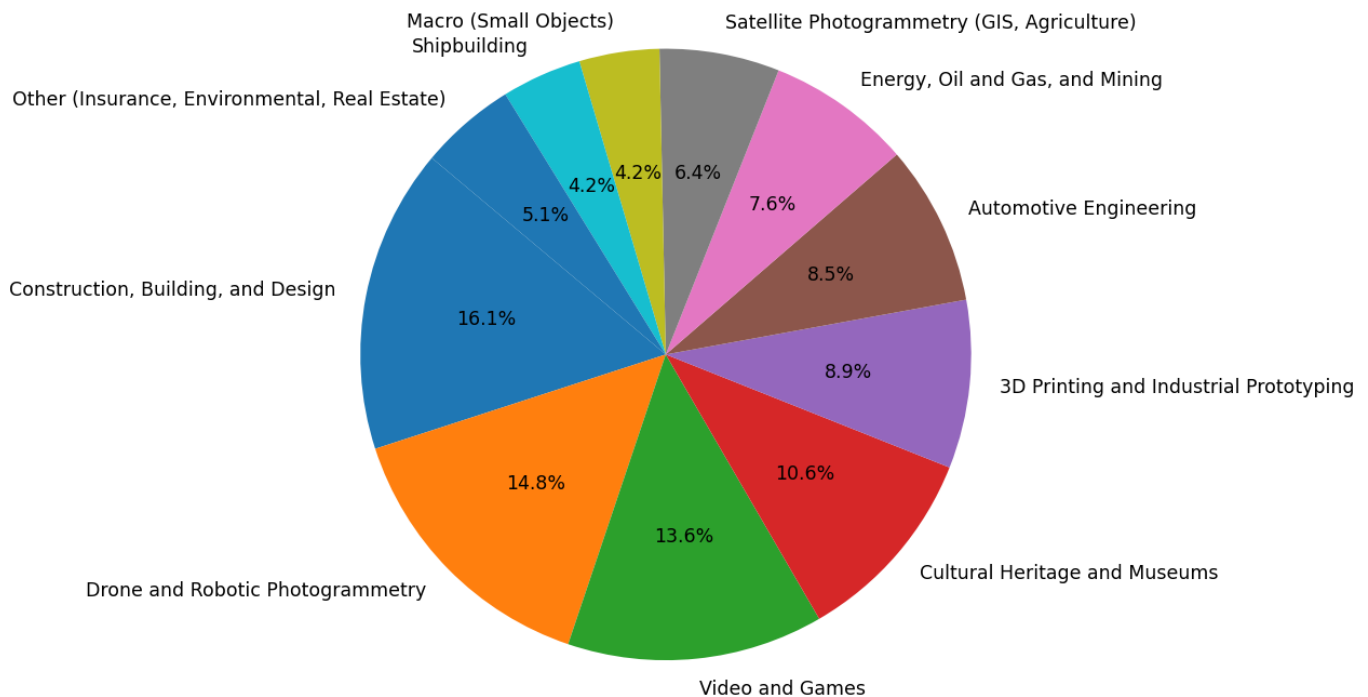
Based on the latest research data [4–13], a comprehensive global overview of photogrammetry applications by sector is summarized in Figure 1.

Figure 1. An overview of photogrammetry applications by sector

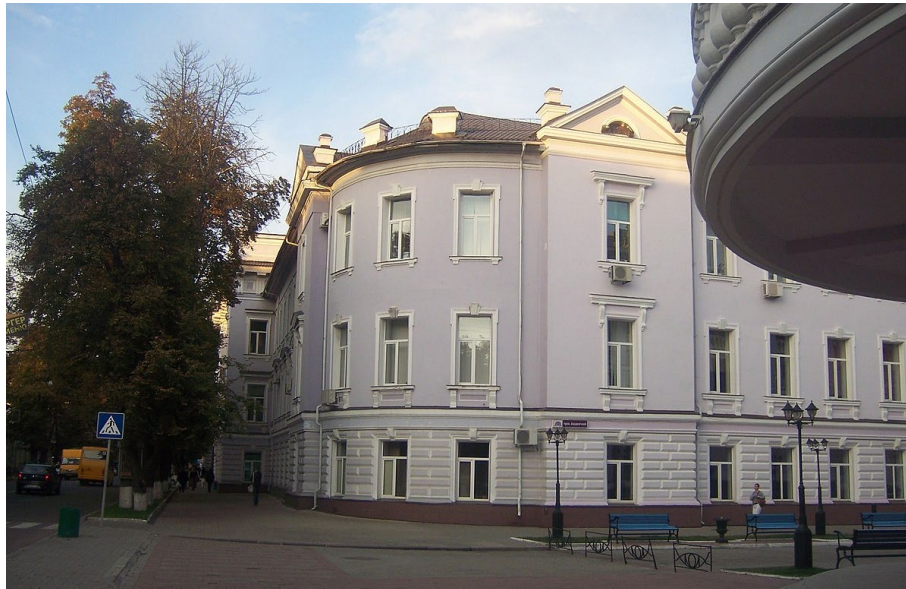
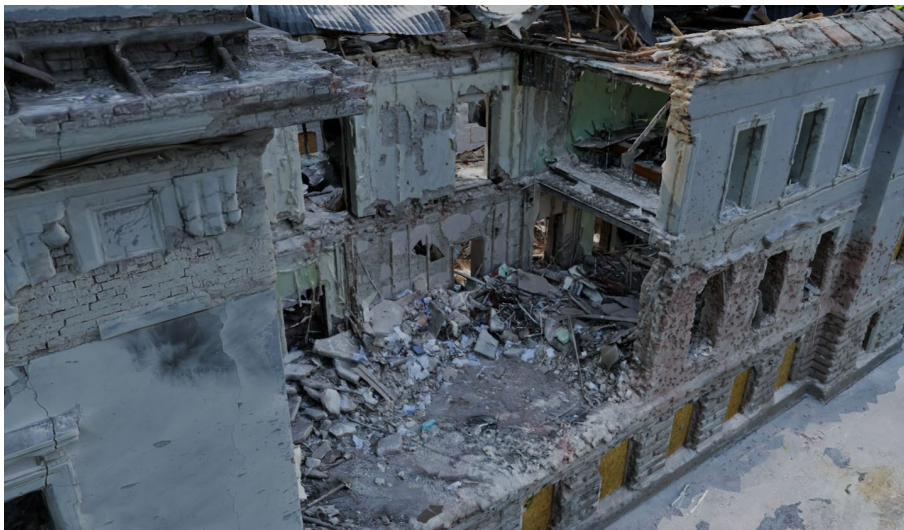
The object of the study was Campus K-2 of Sumy State University (Figure 2a), destroyed by Russian missiles on April 13, 2025, in Sumy, Ukraine (Figure 2b).

Figure 2. Campus K-2 of Sumy State University before (a) and after (b) destruction

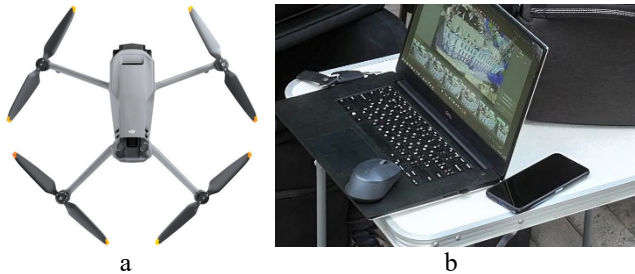
A DJI Mavic 3 Pro UAV (Figure 3) was used to capture the area from various heights and angles.

Figure 3. UAV (a) and workplace (b) for photogrammetry

The drone is equipped by a triple-camera system: a primary 20 MP Hasselblad camera with a 4/3" complementary metal

oxide semiconductor (CMOS) sensor, a medium telephoto 48 MP (1/1.3" CMOS) lens with 3x optical zoom, and a long telephoto 12 MP lens with 7x optical zoom, all stabilized by a 3-axis gimbal. It offers a maximum flight time of up to 43 min, a top speed of 19 m/s, and a control range of up to 15 km via the OcuSync 3+ transmission system.

The drone is also equipped with an omnidirectional obstacle avoidance system featuring 8 sensors for safe flight, supports video recording up to 5.1K at 50 fps and 4K at 120 fps, and includes the DJI RC controller with an 8-inch display and a microSD slot supporting up to 512 GB.
