Exploring the outdoor performance of a LiDAR-based ground plane checking system for the visually impaired

A.B.C. Chai^{1,*} and B.T. Lau²

¹Swinburne University of Technology Sarawak, Malaysia

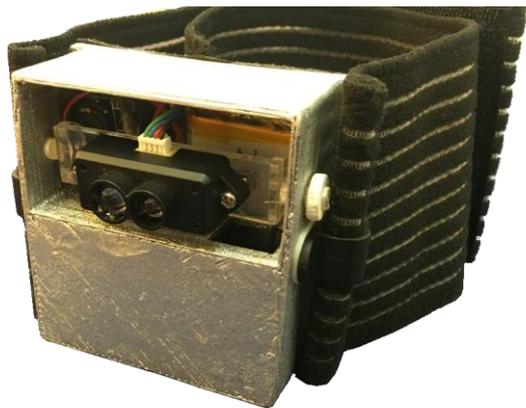
The proposed LiDAR based model consists of a micro LiDAR module, a micro servo motor, a Bluetooth module and an Arduino Pro Mini as the processing unit for the system (Figure 1). The LiDAR based model has three operations: distance sensing with changing pointing direction, ground plane recognition and audible feedback generation. At the start of its operation, the model connects to the mobile phone app through Bluetooth connection. The audible feedback provides information to the user for any changes in the model, including the status and detection results (Figure 2).

Figure 1. LiDAR Based Model.

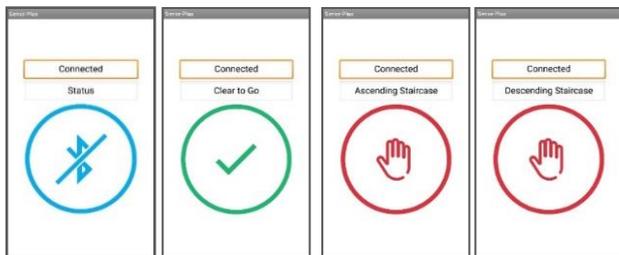
Figure 2. Mobile App Screens.

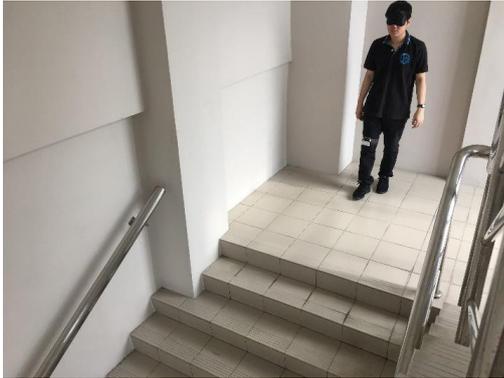
Figure 9 demonstrated the testing conditions for the path-based scenarios. The testing was conducted under normal daylight conditions, with the subject wearing the proposed model and blindfolded. Figure 10 to Figure 19 shows the ten testing scenarios used to test the outdoor ground plane checking performance of the proposed model. The testing followed the route arrows in the figures and each path testing was conducted three times to obtain an average performance of the system.

Figure 9. Testing subject with the model and blindfolded.
