Assesment Of The Air Putih Slab Bengkalis District, RiauProvince (Case Study: RORO Air Putih Wharf)

Keywords: Bridge-Slab Assessment, Finite Element Analysis, Visual Test, Abaqus CAE

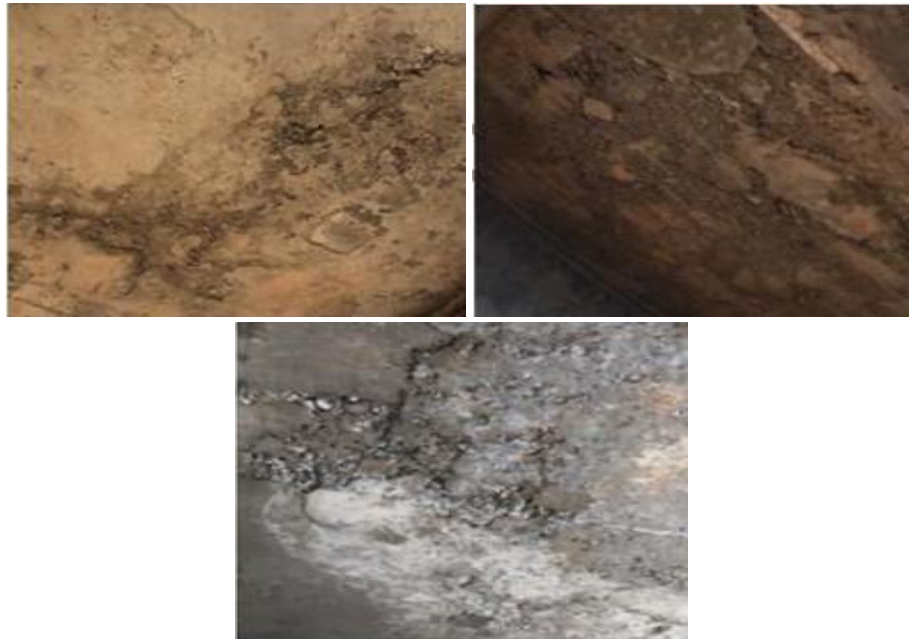
The condition assessment for the damaged element consists of a series of five questions regarding the damage present. The detailed condition value of the bridge is given in accordance with the BMS guideline for bridge inspection by the Directorate General of Highways, Ministry of Public Works of the Republic of Indonesia. From the results of a visual inspection of the condition of the slab in the trestle area visually there is damage in the form of honeycomb so that the condition value of this structure is 2.

Fig. 1. Slab trestle elemental visual condition

From the results of tests carried out by Visual Test, the damage that occurs to the structural elements of the pier slab is a type of Honey Comb damage, where the damage occurs due to peeling of the concrete cover. Then a value of two is obtained for the pier slab structural elements, in which the structural elements are damaged which requires periodic monitoring or maintenance

1. Immediately make repairs to the damaged elements of the wharf structure. Repair existing cracks.
2. Repainting steel elements that have been corroded
3. Always maintain cleanliness in all areas so that early detection can be carried out if damage occurs.
4. Perform routine maintenance such as painting structural components.
5. Conduct structural inspection every 5 years and the review used in this study is an insight for future software application from the concept of the finite element method as an analysis, while the model to be used should be properly calibrated with experimental data so that it will provide the right modeling parameters for later use.

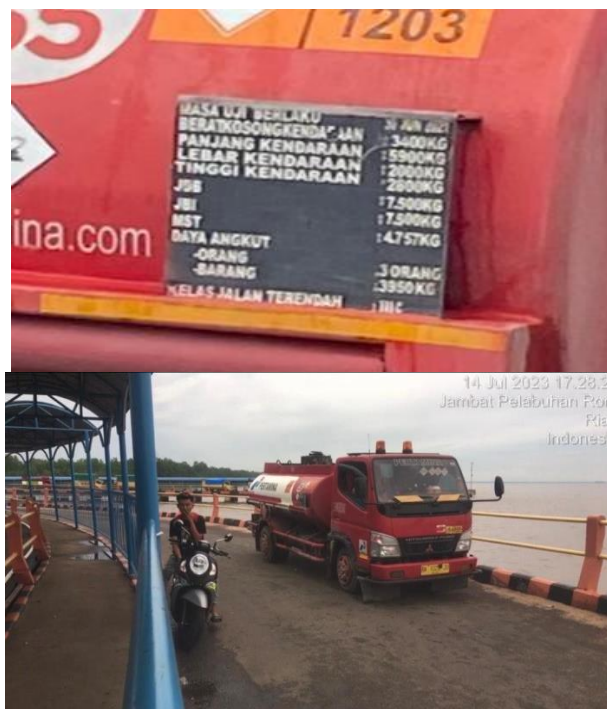
1. The largest weight of the trucks passing through the test area was the Mitsubishi Canter125PS 6 Ban cold diesel oil truck with an empty payload weight of 3400 kg.

Fig. 2. Truck vehicle weigh
Source: 2023 Thesis Documentation

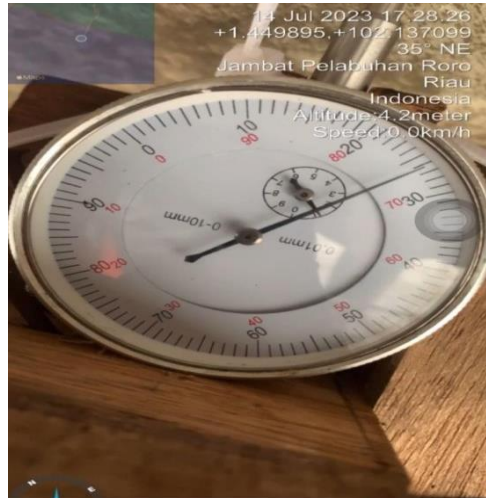
2. The reading data on the Dial Gauge deflection that occurs is 1.26 mm on the structural elements of the pier slab, where the results are obtained from vehicles that pass above it, namely Mitsubishi Canter 125PS 6 tires cold diesel oil trucks with an empty load weight of 3400 Kg or equivalent to 3.4 tons
- 3.

Fig 3. Dial gauge reading results

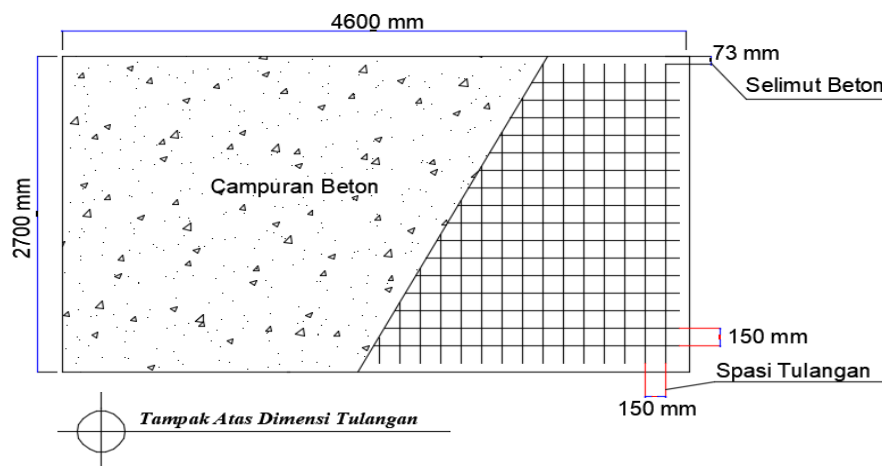
The dimensions of the slab size used are 4600x2700mm, slab thickness is 280 mm and rarely between reinforcement is 150mm. These dimensions are obtained from the results of measurements in the field and the results of the Reebbar Scanning test.

Fig. 5. Slab modeling dimension
