# Repair and Validation of Gear by using Wire Arc Additive Manufacturing

**Abstract.** This paper investigates the repair of damaged gear by using wire arc additive manufacturing. This study focuses on AISI 4340 type gear which is repaired. Single track depositions were used to identify the optimized parameter. The quality of single beads are affected by wire feed rate, current and voltage. The single beads were tested visually, tensile testing and SEM analysis. The AISI 4340 gear has a strength of 900 MPa [4]. The optimized bead has 690 MPa (75% of the original gear) from the tensile testing and the bead has shown no sign of cracks and presence of Micro-void coalescence in traces. The damaged part in the gear was rebuilt in the optimized parameter. Then wire cut EDM and grinding operation were done on the rebuilt part in order to get the original geometry [5]. For validation a gear test rig was used to find the performance of gear under various loading conditions wear analysis.

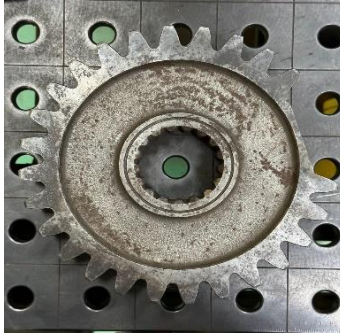
**Figure 2.** Damaged gear

The damaged gear is shown in figure 2. The high strength alloy steel AISI 4340 contains carbon, nickel, chromium and molybdenum [3]. ER 70S is made into 1.2mm diameter wire and a substrate in which the single beads were deposited. The substrate plate is of dimension 150 x 200 x 10 mm. Nine single tracks were deposited on the substrate plate which is further used for finding the optimized parameter. The chemical composition of AISI 4340 substrate is shown in table.1.

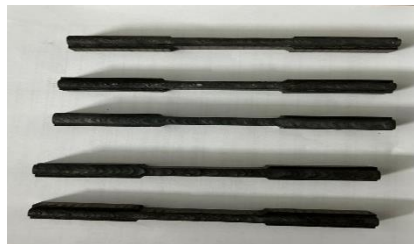
**Figure 4.** Specimen beads for tensile testing

The specimens were investigated for cracks, air gaps and blow holes. The beads were visually investigated for any macroscopic cracks and quality of weld by visual inspection. The visually inspected beads were tested in a tensile testing machine. For the tensile testing the beads were cut by using wire cut EDM in standard tensile testing specimen dimensions. The tensile testing cut beads are shown in figure 4.

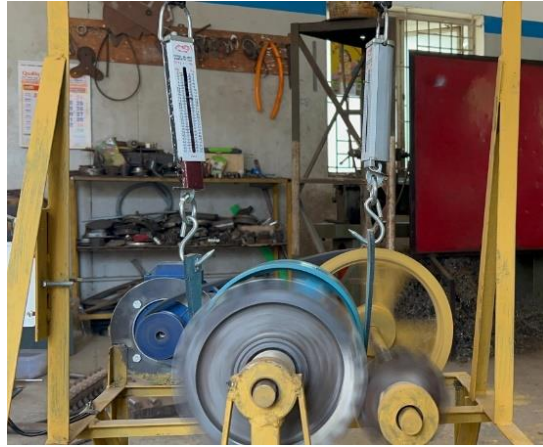
**Figure 12.**Running of gear test rig

The equipment is tested and put through its paces. The brake drum adds resistance as the motor spins it around, simulating the circumstances it will encounter in real operation. This aids in determining whether the equipment is robust enough to support the load without experiencing any issues. We closely monitor the equipment's performance, looking for any indications of problems or malfunctions. When everything works as it should and there are no problems, we may conclude that the gear was successfully repaired and is now fit for use. If the gear passes the functioning test with flying colours, we may exhale with relief. It indicates that the extensive efforts put into fixing it have been fruitful, and we can be confident that it will function dependably once it is operational again. Considering that it saves time and money instead of needing to replace the gear totally, this is a huge victory. Additionally, since we're not tossing away perfectly excellent gear and creating new ones from start, it's beneficial for the environment.

All things considered; the functionality test is an essential part of the gear repair procedure. The knowledge that the equipment is in good condition and prepared for use again provides us with piece of mind. We can also be certain that the equipment will function just as it did when it was brand-new because of the meticulous testing and attention to detail. Therefore, we can rely on any gearbig or smallto do its function without any problems, whether it's in a factory or a machine.as shown in figure 12 running of gear test rig.
