# Assessing Soil Engineering Properties for Landslide Susceptibility in Karo Regency, Indonesia

Civil Engineering Study Program, Universitas Negeri Medan, Jl. Willem Iskandar Psr.V, Medan, Sumatera Utara, Indonesia, 2022<sup>1,2,3</sup>

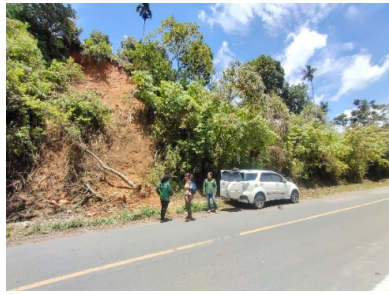
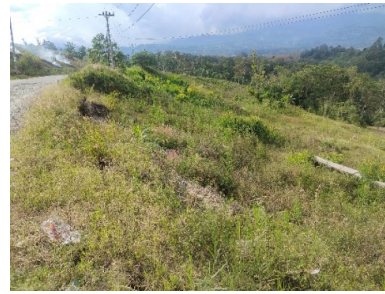
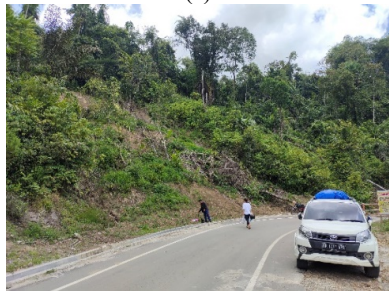
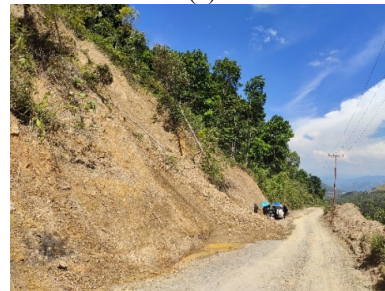
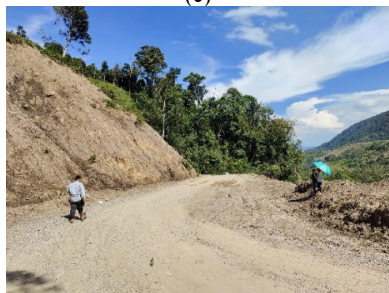
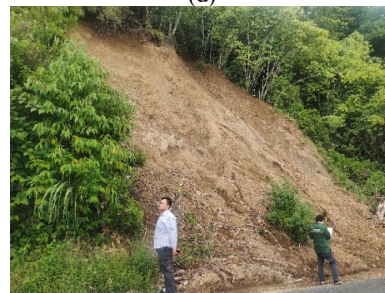
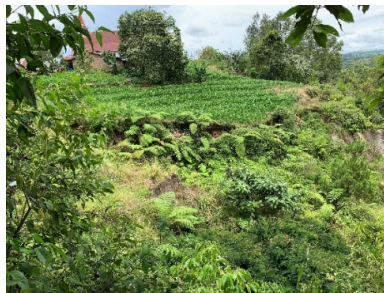
**Fig. 2.** Condition of soil testing points in the field: (a) Kutabuluh; (b) Sarinembah; (c) Kutabelin; (d) Jl. Trans Liang Melas Datas (location 1); (e) Jl. Trans Liang Melas Datas (location 2); (f) Jalan Lintas Berastagi-Lau Kawar; (g) Kutambaru.

The measurement of slope geometry was conducted using a laser distance meter telescope, as depicted in Fig. 2, which illustrates the conditions of the measured slope. From the measurements of the slope geometry, it was determined that the mass movement classification is predominantly characterized by translational mass movement of soil/rock, with materials consisting of debris and soil in the landslide. Furthermore, the type of landslide at the Sarinembah location exhibits a distinct classification compared to other sites, characterized as lateral spreading, specifically soil creep. Detailed classifications of mass movements of soil or rock can be found in Table 3.

The results of soil bulk density testing are essential for determining the natural soil density in the field. These values are subsequently employed in the process of creating soil mechanical testing samples in the laboratory, such as Triaxial tests. A steel core barrel with internal dimensions of 36 mm in diameter and 72 mm in height serves as the tool for obtaining soil bulk density values in the field (Fig. 3a). Sampling is carried out on the surface of the natural soil around the landslide and the landslide slip surface (Fig. 3b). Table 4 provides a summary of the soil bulk density test results from the three research-focused locations. These results reveal that the landslide soil characteristics in Kutambelin are denser compared to the other locations. The landslides in this area are primarily attributed to steep slope cutting for the road without adequate reinforcement or erosion control measures (Fig. 2c).

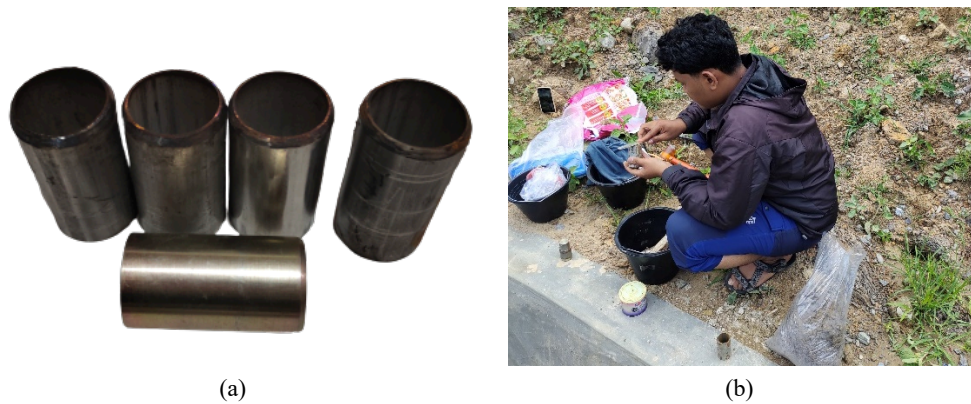
**Fig. 3.** In situ bulk density: (a) steel core barrel; (b) sampling process.
