Camera-Based Road Damage Detection System with Edge Detection Algorithm

Abstract. Road is one of the transportation infrastructure which is very important for vehicle in riding activity. The vehicle is growing every year, road infrastructure should be getting attention for comfortable and safety in riding. However, there are still many apprehensive road condition in the form of damaged roads, especially potholes. One of the problem in repairing road is road damage detection process which is done manually by the human, by this way the process needs a longer time. This research develops road damage detection system by using image processing and road damage mapping which are saved in database. This system uses webcam for capturing the road in real time, webcam is located in front of vehicle and GPS module is used for marking road damage location which is controlled by arduino uno microcontroller.

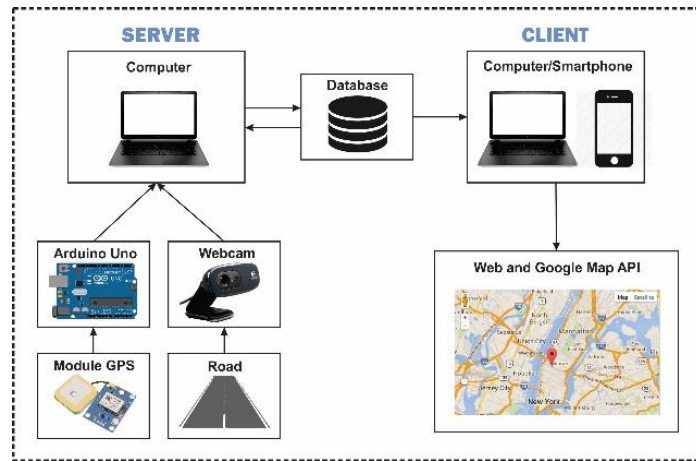
Fig. 1. How the System Works Generally.

The system designed in this study is used to detect road damage by receiving input in the form of asphalt surface video data from webcam and it will be processed by computer. Image data from the video consists of multiple frame images which is displayed simultaneously, and continuously processed by using image-processing techniques to detect road damage objects. This system is divided into two processes, namely: the process of detecting road damage; and the process of storing the data into the database. In general, the way the system works is illustrated in figure 1.

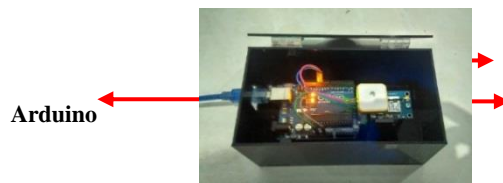
Fig. 4. GPS Module Testing.

Figure 4 is a GPS module testing to get the data about latitude and longitude of a location.
