# Analysis of superficial groundwater quality in the ex-manganese mine in the kliripan hamlet of hargorejo village, kokap district, kulonprogo.

**Abstract:** Manganese ore mining in the Kliripan area was initially carried out by the Dutch colonial government until the independence of the Republic of Indonesia. After independence the Manganese ore mining activity in Kliripan was continued by the Government of Indonesia until the end of 1983. The quality of water consumed, as well as the quality of water in lakes, streams, rivers and oceans, is an important parameter in determining the overall quality of life. Water quality is determined by the solute and the gas dissolved in the water, as well as the suspended material and floating on the water.

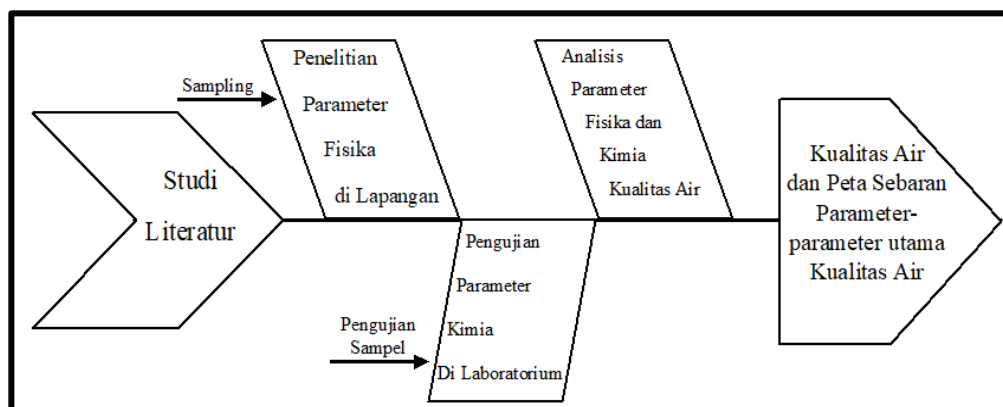
Fig. 1. Water Quality Research Methods

Research on the parameters of ground water quality in the community dug wells around the hole opened by Manganese ore mining in Kliripan Hamlet, Kokap District, Kulon Progo Regency can be seen in Figure 1 using the fishbone diagram

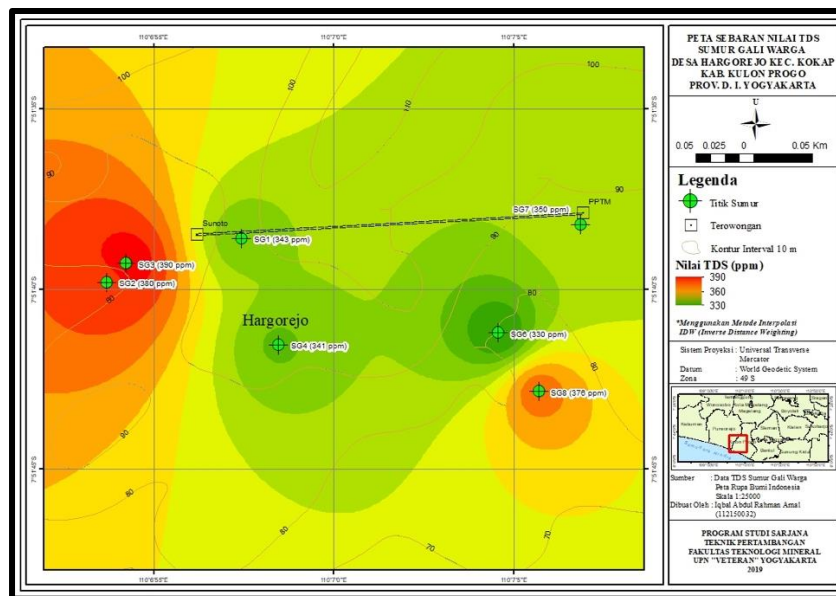
Fig. 5. Peta Sebaran Parameter Fisik *Total Dissolved Solids* (TDS)

Distribution of physical parameters of Total Dissolved Solids (TDS) of ground water in Figure 5 which shows the results of water quality parameters in the study area. Based on the distribution map, the TDS parameters with high values are symbolized by the gradation of red (390 mg / L) at the well points SG 2 (380 mg / L) and SG 3 (390 mg / L) which are located on the west. TDS parameters with values  $<380$  mg / L are symbolized by gradations of orange (360 mg / L) and green (330 mg / L) found in wells SG 1 (343 mg / L), SG 4 (341 mg / L), SG 6 (330 mg / L), SG 7 (350 mg / L) and SG 8 (376 mg / L).

Physical parameters of groundwater TDS in the study area can be classified into fresh water. Based on the Republic of Indonesia Government Health Regulation No. 492 / Menkes / Per / IV / 2010, the maximum permissible TDS value is 500 mg / L so that the water in the area is suitable for use as clean water and drinking water.

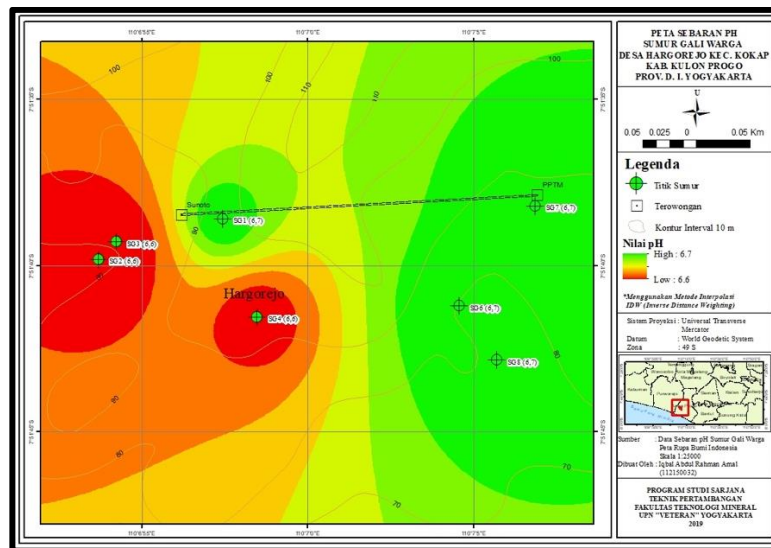
Fig. 6. Peta Sebaran Parameter Kimia Derajat Keasman (pH)

Distribution of chemical parameters of the acidity (pH) of ground water in Figure 6 which shows the results of the water quality parameters in the study area. Based on the pH distribution map, the pH values at the well points SG 2 (6.6), SG 3 (6.6) and SG 4 (6.6) have the same pH value which is symbolized by a gradation in red. Whereas at the well points SG 1 (6.7), SG 6 (6.7), SG 7 (6.7) and SG 8 (6.7) are symbolized by gradations of green.

The pH value of ground water in the study area did not show any significant difference with the difference in pH value of 0.1. According to the Republic of Indonesia Government Health Regulation No. 492 / Menkes / Per / IV / 2010 concerning the parameters of drinking water quality requirements, water in the area is suitable for use as clean water and drinking water based on chemical parameters of pH.
