Identification of Testing Soil Physical Properties Through Landslide Material Characterization

Abstract. The characteristics of soil material that has landslide are known by carrying out initial soil testing, that is the physical properties of the soil which is carried out in the laboratory. Aek Parombunan, Hutabarangan, Pancuran Gerobak, and Pancuran Dewa in Sibolga city, are areas where landslides have occurred and this is used as a place for taking soil samples. The test results show soil samples for all four areas are classified as silty/clayey types of gravel and sand material, based on the AASHTO classification. The influence of the Atterberg value on the soil plasticity index value is included in low category (no potential for the soil to expand), but if you look at the porosity value of the soil material that has collapsed, it is on the medium threshold, which means that there is still space or gaps for water movement and this can cause subsidence or landslides.

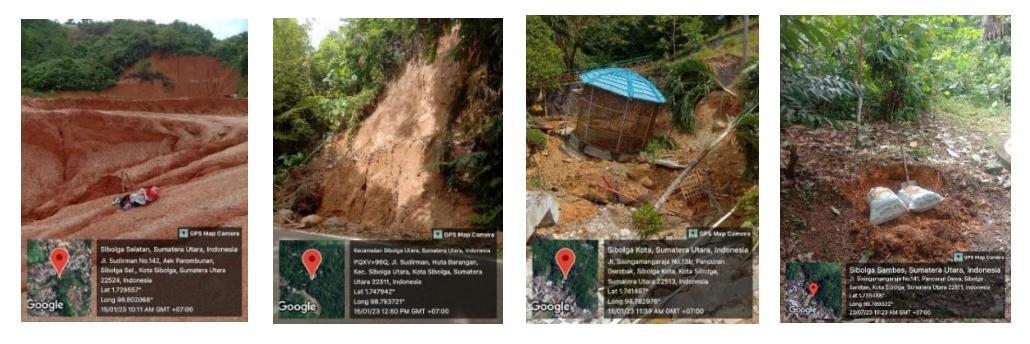
(a) (b) (c) (d) **Fig. 1.** Sampling Location (a). Aek Parombunan; (b). Hutabarangan; (c). Pancuran Gerobak; (d) Pancuran Dewa.

The types of soil that will be tested in this research are taken from four (4) locations on the land slopes where landslides have occurred. The first location is in the area of Aek Parombunan which is at the Street of Sudirman, in the sub-districts of South Sibolga, the second location is in the area of Hutabarangan which is at the street of Sudirman, in the sub-districts of North Sibolga, the third location is in the area of Pancuran Gerobak which is at the street of SM Raja, in the sub-districts of Sibolga town and the fourth location is in the area of Pancuran Dewa which is at the street of Sisingamangaraja, in the sub-districts of Sibolga Sambas that can be shown as in the Figure 1 below.
